TMS320F28P65x Real-Time MCUs Silicon Errata

Silicon Revisions A, 0

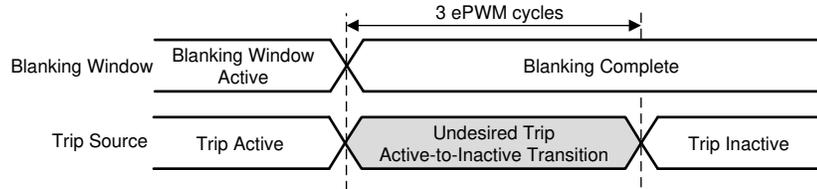
Figure 3-1. Undesired Trip Event and Blanking Window Expiration

Details The blanking window is typically used to mask any PWM trip events during transitions which would be false trips to the system. If an ePWM trip event remains active for less than three ePWM clocks after the end of the blanking window cycles, there can be an undesired glitch at the ePWM output.

Figure 3-1 illustrates the time period which could result in an undesired ePWM output.

Workaround Extend or reduce the blanking window to avoid any undesired trip action.
