IWR6843, IWR6443 Device Silicon Errata Silicon Revisions 1.0 and 2.0

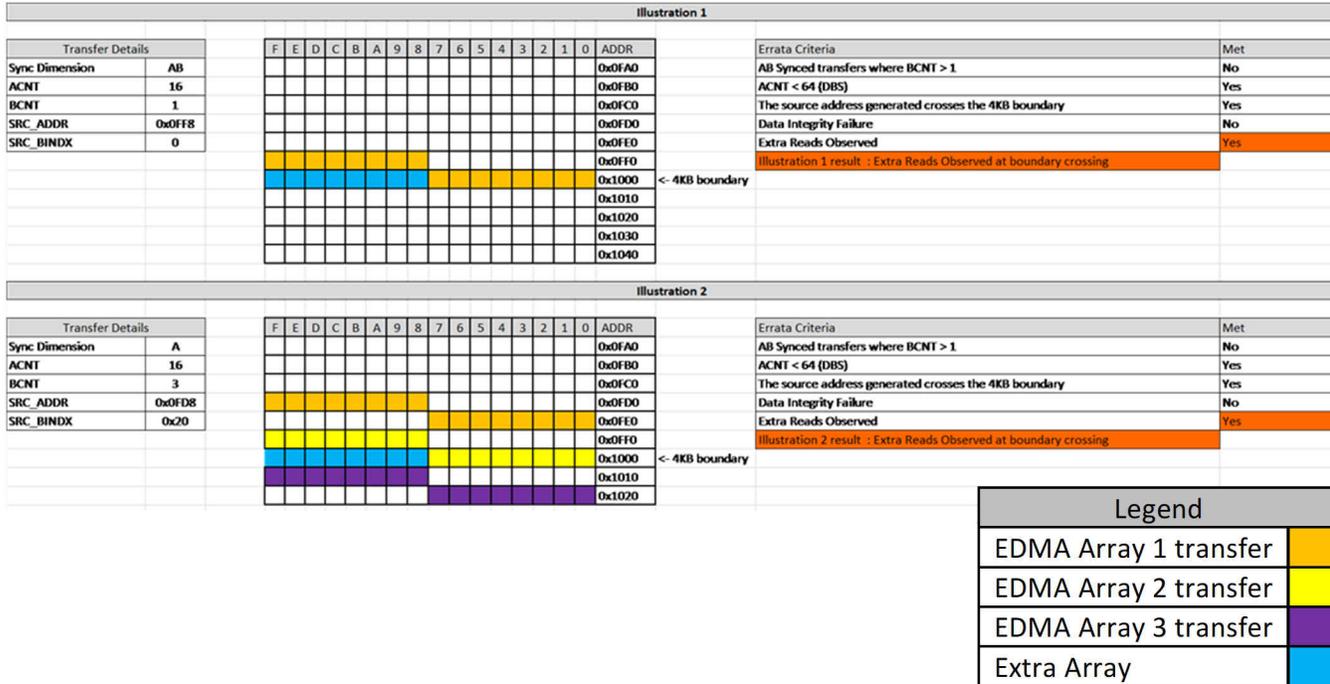
Figure 6-1. Scenario ID #3 – Extra Reads

For each extra read in **Scenario ID #3** for which **Condition [1]** is applicable, each index i above that satisfies the condition results in extra read from starting address SRC_ADDR + (i + 1) * SRCBIDX and of length equal to the distance from the start address to the boundary [that is, 0x1000 – X(i)]. Note: length < ACNT.

For **Scenario ID #3, Scenario ID #4, and Scenario ID #5**– EXTRA READS, another workaround besides avoiding the 4-KB boundary cross conditions, is to ensure that buffers involved in this kind of transfer are positioned so that extra reads stay within the physical memory boundaries. If the extra reads go to Reserved space or space blocked by the Memory Protection Unit (MPU), the TPTC generates a bus error interrupt to the processor.

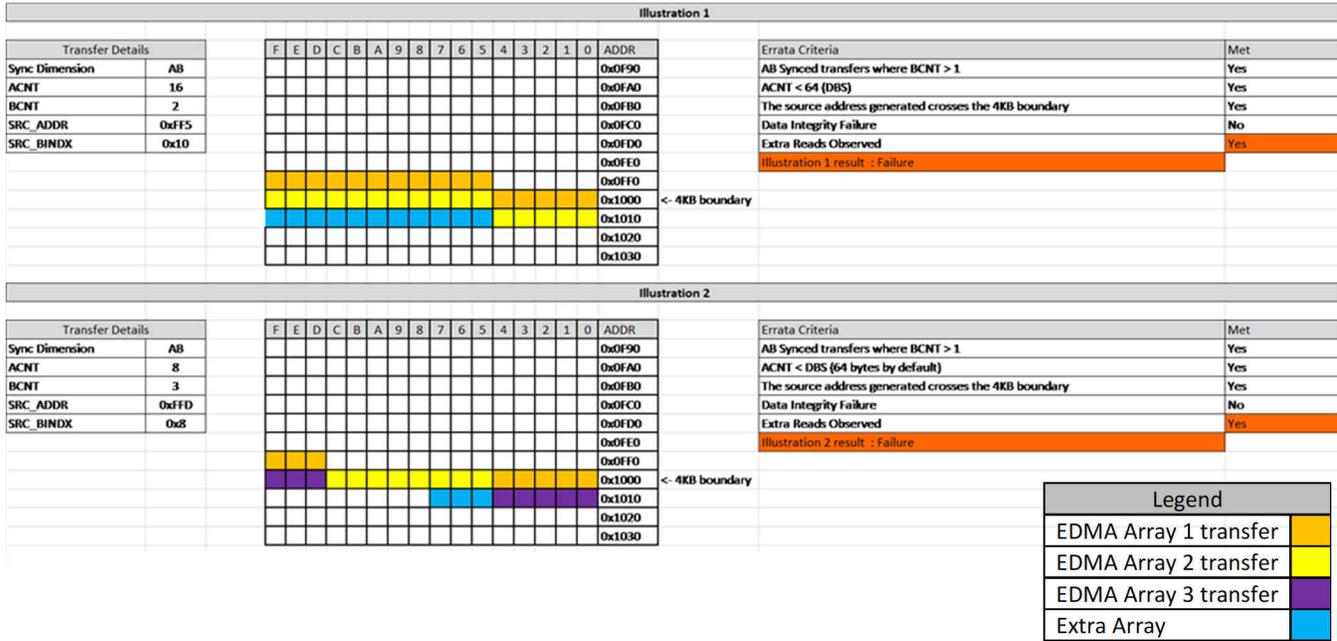
Figure 6-2. Scenario ID #4 – Extra Reads

For each extra read **Scenario ID #4** in for which **Condition [1]** is applicable, there is an extra read from starting address SRC + BCNT * ACNT (=SRCBIDX) of length equal to the distance of the start address to the boundary [that is, length is 0x1000 – X(i)], where i is the index of one and only 4-KB boundary crossing condition. Note: length < ACNT.

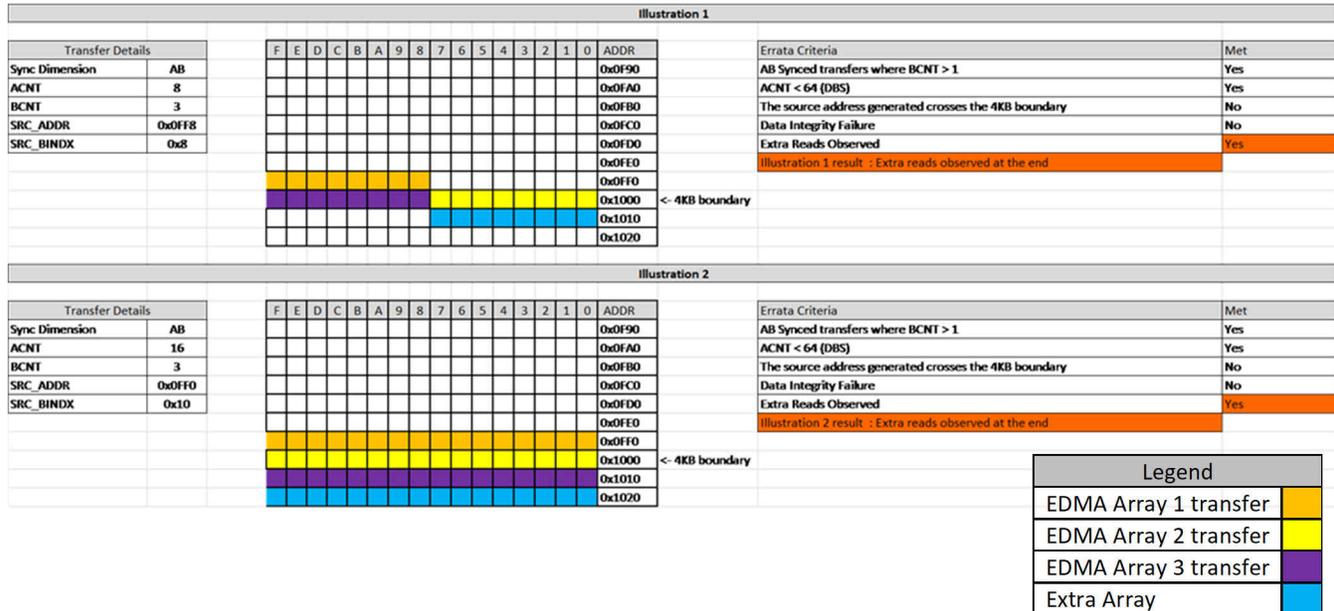
Figure 6-3. Scenario ID #5 – Extra Reads

For the extra read **Scenario ID #5** in for which **Condition [2]** is applicable, there is an extra read from starting address SRC + BCNT * ACNT (=SRCBIDX) of length equal to the distance of the start address and is of length ACNT.
