MSP430F2012 Device Erratasheet

6 Detailed Bug Description

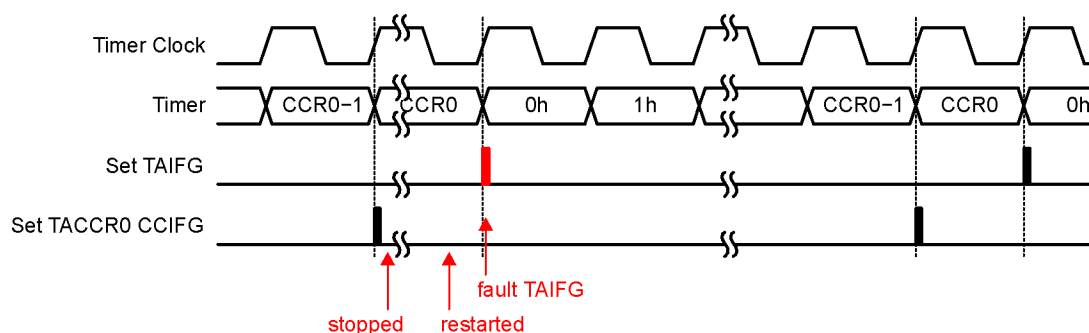
TA21
TIMER_A Module
Category

TAIFG Flag is erroneously set after Timer A restarts in Up Mode

In Up Mode, the TAIFG flag should only be set when the timer counts from TACCR0 to zero. However, if the Timer A is stopped at TAR = TACCR0, then cleared (TAR=0) by setting the TACLK bit, and finally restarted in Up Mode, the next rising edge of the TACLK will erroneously set the TAIFG flag.

Workaround None.
