# MSP430F436 Device Erratasheet

## 1 Functional Errata Revision History

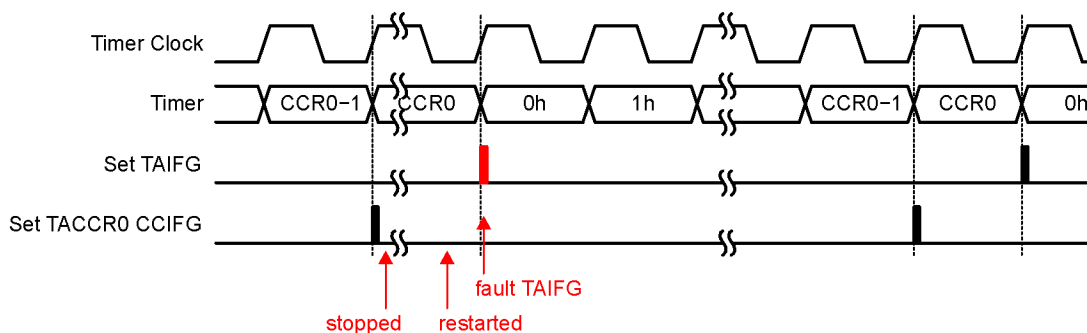
## TA21 *TIMER\_A Module*

**Function** TAIFG Flag is erroneously set after Timer A restarts in Up Mode

**Description** In Up Mode, the TAIFG flag should only be set when the timer counts from TACCR0 to zero. However, if the Timer A is stopped at TAR = TACCR0, then cleared (TAR=0) by setting the TACLR bit, and finally restarted in Up Mode, the next rising edge of the TACLK will erroneously set the TAIFG flag.

**Workaround** None.

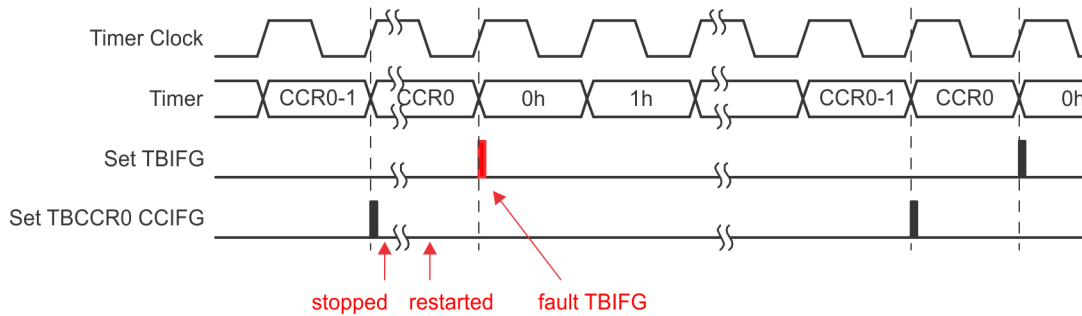
**Function** TBIFG Flag is erroneously set after Timer B restarts in Up Mode

**Description** In Up Mode, the TBIFG flag should only be set when the timer resets from TBCCR0 to zero. However, if the Timer B is stopped at TBR = TBCCR0, then cleared (TBR=0) by setting the TBCLR bit, and finally restarted in Up Mode, the next rising edge of the TBCLK will erroneously set the TBIFG flag.

**Workaround** None.
