MSP430F437 Device Erratasheet

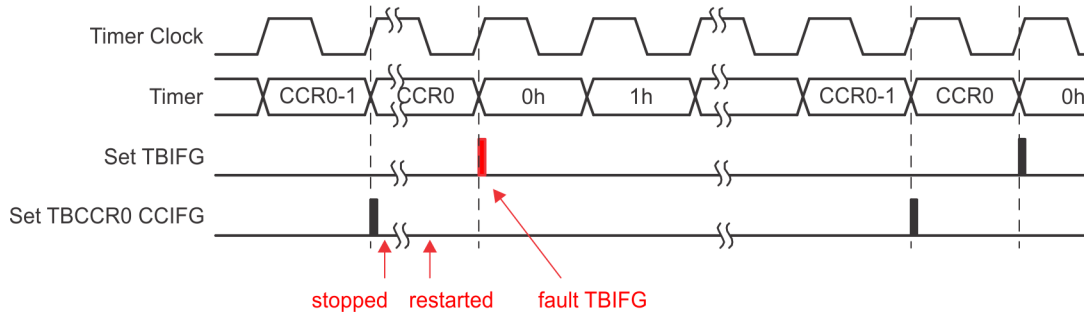
Function TBIFG Flag is erroneously set after Timer B restarts in Up Mode

Description In Up Mode, the TBIFG flag should only be set when the timer resets from TBCCR0 to zero. However, if the Timer B is stopped at TBR = TBCCR0, then cleared (TBR=0) by setting the TBCLR bit, and finally restarted in Up Mode, the next rising edge of the TBCLK will erroneously set the TBIFG flag.

Workaround None.
