MSP430F5326 Device Erratasheet

The revision of the device can be identified by the revision letter on the [Package Markings](#) or by the [HW_ID](#) located inside the TLV structure of the device

7 Detailed Bug Description

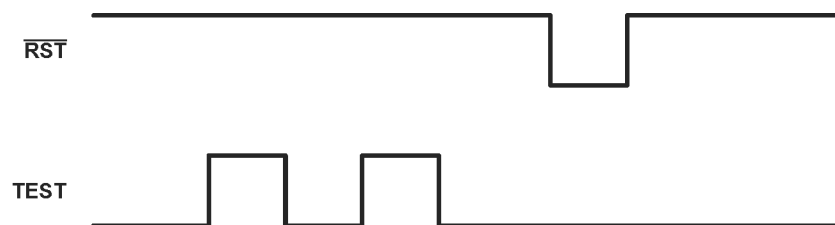
- Toggle the TEST pin twice when nRST is high and after 50us pull nRST low.

Note: This toggling of TEST pins is not subject to timing constraints. The appropriate level transitions on TEST pin, followed by a RST pulse after 50us, are sufficient to trigger an exit from BSL mode.
