# MSP430G2253 Device Erratasheet

## 1 Functional Errata Revision History

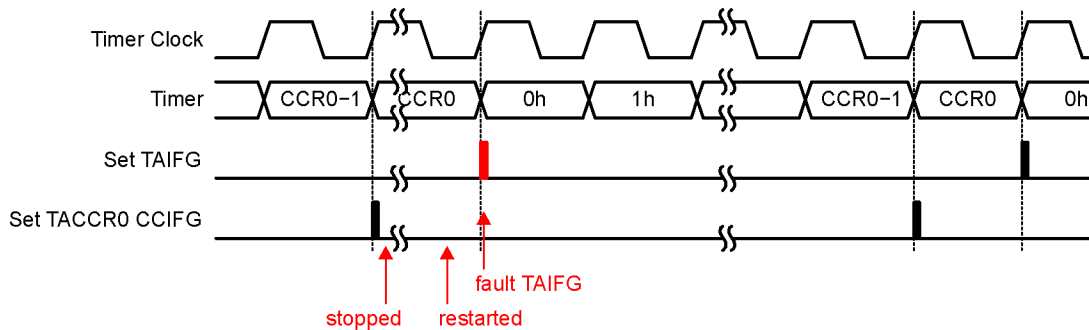
**Function** TAIFG Flag is erroneously set after Timer A restarts in Up Mode

**Description** In Up Mode, the TAIFG flag should only be set when the timer counts from TACCR0 to zero. However, if the Timer A is stopped at TAR = TACCR0, then cleared (TAR=0) by setting the TACLR bit, and finally restarted in Up Mode, the next rising edge of the TACLK will erroneously set the TAIFG flag.

**Workaround** None.
