# **TMS320C2834x Delfino™ MCUs**

## **Silicon Revision 0**

### **1 Introduction**

This document describes the silicon updates to the functional specifications for the TMS320C2834x microcontrollers (MCUs).

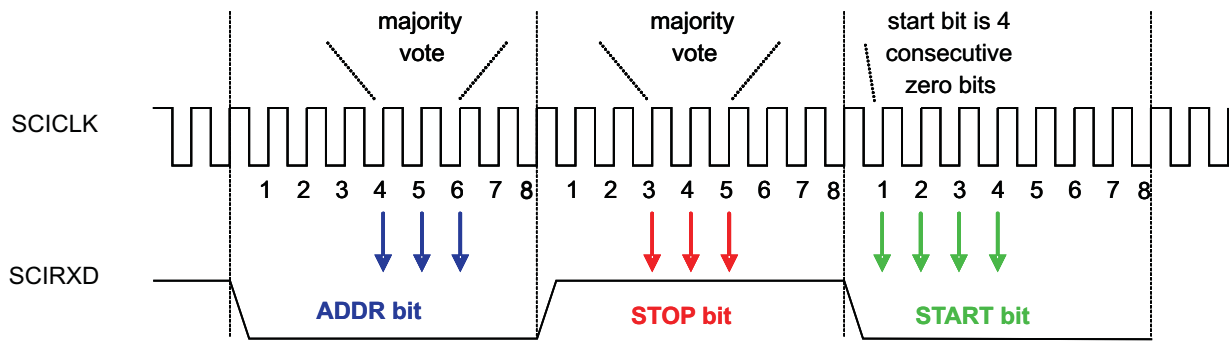
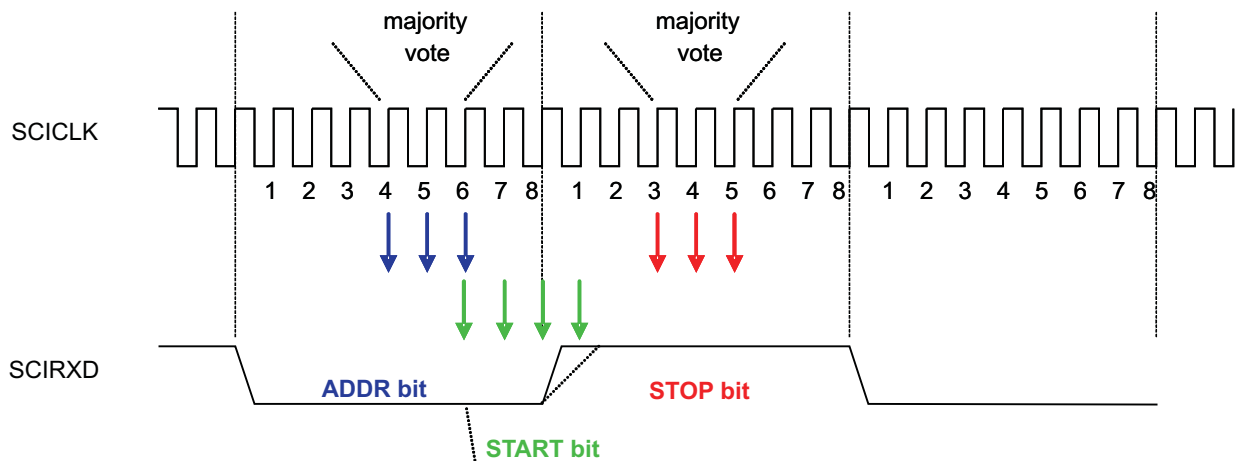
**Figure 3. Difference Between Expected and Erroneous Operation of START Bit**

**Advisory** *SCI: Incorrect Operation of SCI in Address Bit Mode*

**Details** SCI does not look for STOP bit after the ADDR bit. Instead, SCI starts looking for the start bit beginning on sub-sample 6 of the ADDR bit. Slow rise-time from ADDR to STOP bit can cause the false START bit to occur since the 4th sub-sample for the start bit may be sensed low.

*Expected Operation:*

*Erroneous Operation:*

**Workaround(s)** Program the baud rate of the SCI to be slightly slower than the actual. This will cause the 4th sub-sample of the false START bit to be delayed in time, and therefore occur more towards the middle of the STOP bit (away from the signal transition region). The amount of baud slowing needed depends on the rise-time of the signal in the system. Alternatively, IDLE mode of the SCI module may be used, if applicable.
