# **TMS320F2833x, TMS320F2823x DSCs Silicon Errata Silicon Revisions A, 0**

This document describes the silicon updates to the functional specifications for the TMS320F2833x and TMS320F2823x digital signal controllers (DSCs).

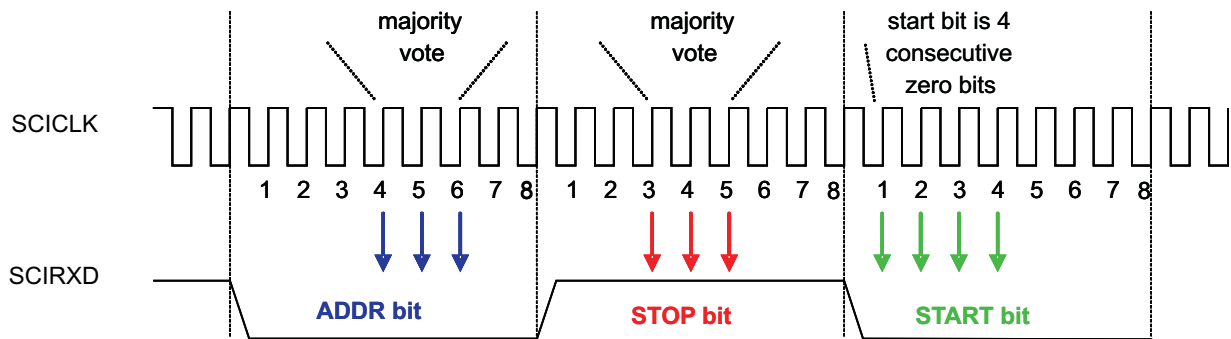
**Figure 3. Difference Between Expected and Erroneous Operation of START Bit**

**Details** SCI does not look for STOP bit after the ADDR bit. Instead, SCI starts looking for the start bit beginning on sub-sample 6 of the ADDR bit. Slow rise-time from ADDR to STOP bit can cause the false START bit to occur since the 4th sub-sample for the start bit may be sensed low.

**Workaround(s)** Program the baud rate of the SCI to be slightly slower than the actual. This will cause the 4th sub-sample of the false START bit to be delayed in time, and therefore occur more towards the middle of the STOP bit (away from the signal transition region). The amount of baud slowing needed depends on the rise-time of the signal in the system. Alternatively, IDLE mode of the SCI module may be used, if applicable.

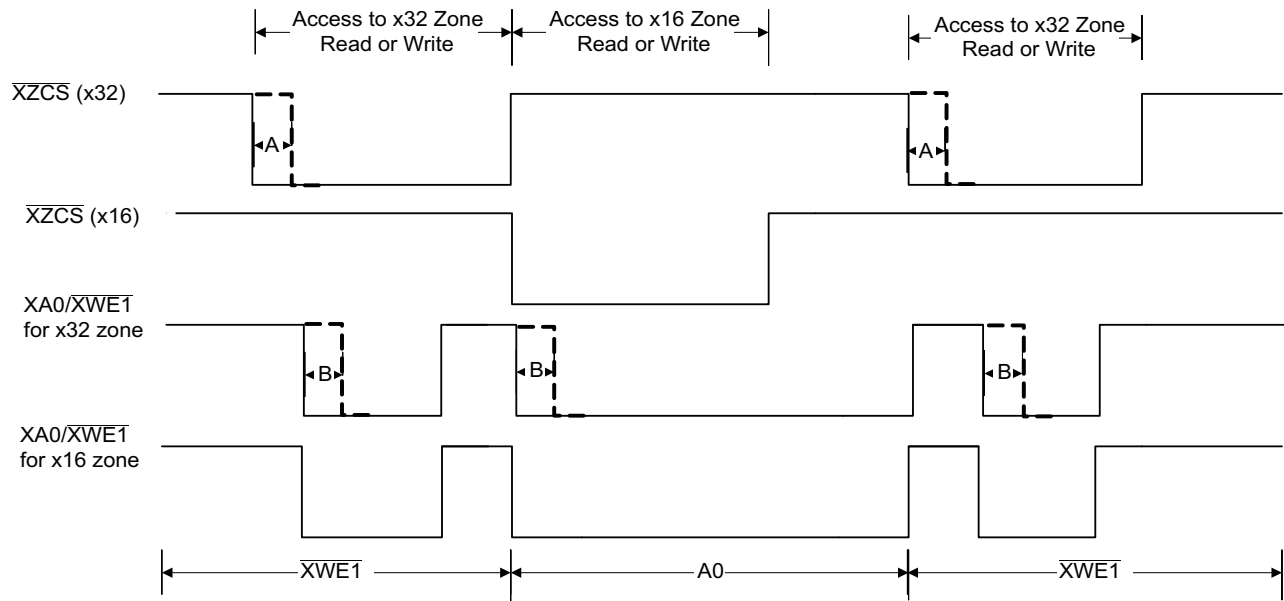
**Figure 8. Behavior After Application of Delay**

- A Delayed falling edge of zone chip select for x32 zone.
- B Delayed falling edge of  $\overline{XWE1}$ . The x16 zone will not see this delay.

5. Configure the GPIO MUX registers for XINTF operation.
3. Use external logic to delay the falling edge of the x32 zone chip select signal and the falling edge of the XWE1 signal as shown in Figure 8. With the delay the x32 zone chip select sees the XWE1 signal high at the critical points.

The timing configuration of the x32 zone must account for the additional delay. The zone chip select delay may require additional lead time. The  $\overline{XWE1}$  delay enable may require additional active write time. In addition, specify at least 1 trail cycle for writes to the x32 zone.
