TMS320F2802x, TMS320F2802xx Piccolo™ MCUs Silicon Revisions B, A, 0

1 Introduction

This document describes the silicon updates to the functional specifications for the TMS320F2802x and TMS320F2802xx microcontrollers (MCUs).

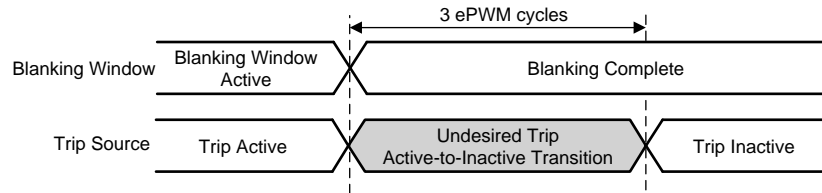
Figure 5. Undesired Trip Event and Blanking Window Expiration

Details The blanking window is typically used to mask any PWM trip events during transitions which would be false trips to the system. If an ePWM trip event remains active for less than three ePWM clocks after the end of the blanking window cycles, there can be an undesired glitch at the ePWM output.

Figure 5 illustrates the time period which could result in an undesired ePWM output.

Workaround(s) Extend or reduce the blanking window to avoid any undesired trip action.
