# ***F28M35x Concerto™ MCUs Silicon Errata Silicon Revisions E, B, A, 0***

## **1 Introduction**

This document describes the silicon updates to the functional specifications for the F28M35x microcontrollers (MCUs).

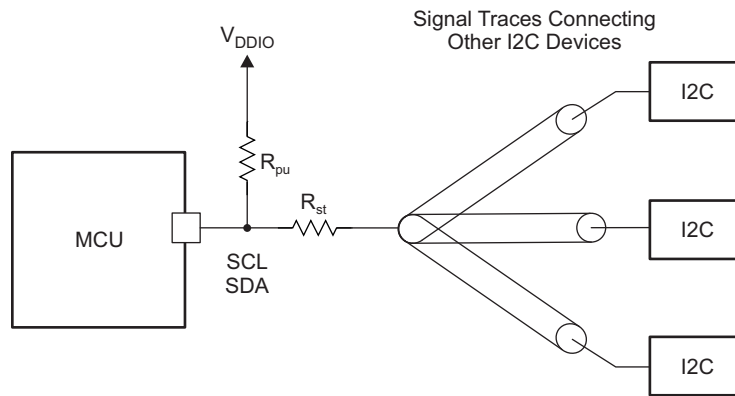
**Figure 8. Placement of Series Termination Resistor and Pullup Resistor**

The SDA and SCL outputs are implemented with push-pull 3-state output buffers rather than open-drain output buffers as required by I2C. While it is possible for the push-pull 3-state output buffers to behave as open-drain outputs, an internal timing skew issue causes the outputs to drive a logic-high for a duration of 0–5 ns before the outputs are disabled. The unexpected high-level pulse will only occur when the SCL or SDA outputs transition from a driven low state to a high-impedance state and there is sufficient internal timing skew on the respective I2C output.

This short high-level pulse injects energy in the I2C signals traces, which causes the I2C signals to sustain a period of ringing as a result of multiple transmission line reflections. This ringing should not cause an issue on the SDA signal because it only occurs at times when SDA is expected to be changing logic levels and the ringing will have time to damp before data is latched by the receiving device. The ringing may have enough amplitude to cross the SCL input buffer switching threshold several times during the first few nanoseconds of this ringing period, which may cause clock glitches. This ringing should not cause a problem if the amplitude is damped within the first 50 ns because I2C devices are required to filter their SCL inputs to remove clock glitches. Therefore, it is important to design the PCB signal traces to limit the duration of the ringing to less than 50 ns. One possible solution is to insert series termination resistors near the SCL and SDA terminals to attenuate transmission line reflections.

Insert series termination resistors on the SCL and SDA signals and locate them near the SCL and SDA terminals. The SCL and SDA pullup resistors should also be located near the SCL and SDA terminals. The placement of the series termination resistor and pullup resistor should be connected as shown in [Figure 8](#).

Table 8 provides series termination and pullup resistor value recommendations. The I2C signal level and respective  $V_{DDIO}$  power supply voltage is shown in the first column. Two resistor value combination options are provided for each voltage. One option supports a maximum high-level input current of 200  $\mu A$  to all attached I2C devices, while the other option supports a maximum high-level input current of 100  $\mu A$  to all attached I2C devices.
