TDA2Px SoC for Advanced Driver Assistance Systems (ADAS) Silicon Revision 1.0

1 Introduction

This document describes the known exceptions to the functional specifications for the device.

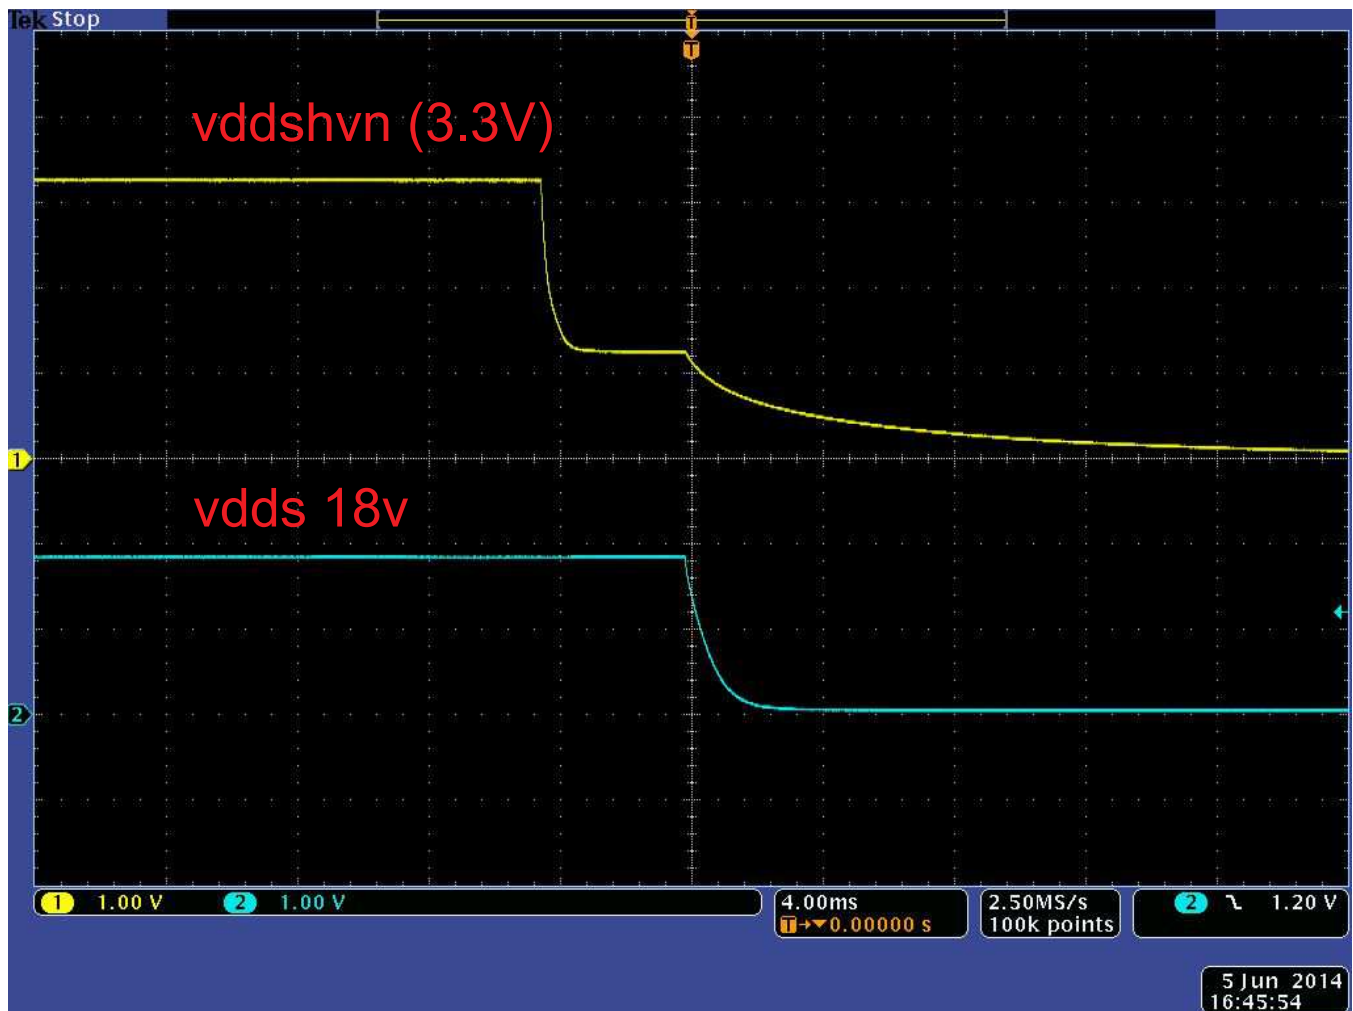
Figure 2. PAB_RevA

A subset of the SOC's LVCMOS IOs (refer to DM for details) have a pull-up resistor that is active by default, including during reset and power-down. The SOC's IOs that have internal or external pull-ups will stay at Plateau Level (<1.5V) during the power-down. If other ICs on the board that are interfaced to the SOC's LVCMOS signals use a separate supply then it's possible that the other IC's signals can be pulled to the Plateau Level while its power supply is off.

The root cause of the plateau is related to the LVCMOS IO buffer Dual Voltage detection circuitry. The LVCMOS Dual Voltage IO includes voltage comparator circuitry to determine if the IO is in 3.3V mode or 1.8V mode. During powerdown of vddshvn domains, a current path in the internal bias transistors results in the vddshvn rail being held to an intermediate voltage level (<1.5 V). This path can consume at most 500 uA per IO - worst case estimate is ~150 mA (based on 280 IOs) from the vdds18v supply

during power down. This path is not a reliability concern for the device.

In general, TI recommends using the same supply source for connected components. E.g., a single LDO should drive vddshvn and the related 3.3V external components.

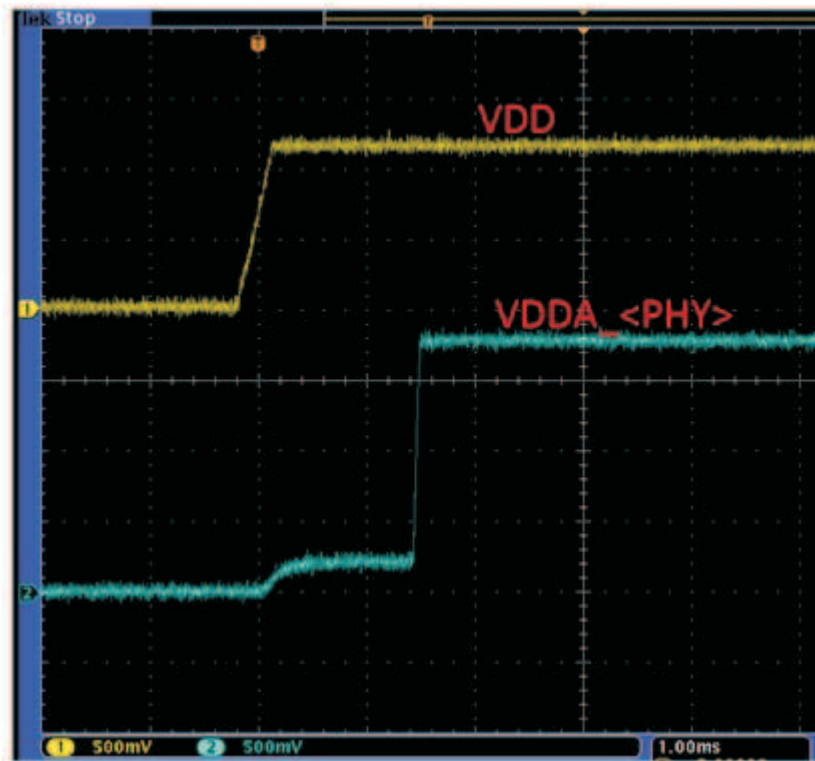
Figure 3. Leakage Voltage

The device-specific Data Manual requires Core AVS rail (VDD) to power up before the 1.8 V high speed analog PHY domain(s). When this sequence is followed, the high speed analog PHY domain will have a small step-up to a voltage plateau (< 0.5 V) that aligns to the beginning of the VDD ramp-up, and is maintained until the ramp-up of high speed analog PHY rail, as shown in [Figure 1](#). Note the leakage value will differ from system to system, but will be less than 500 mV. The leakage voltage in the provided capture is approximately 250 mV.

The reverse is true on the power down sequence. The high speed analog PHY domain(s) are required to be powered down prior to Core AVS rail (VDD), and such sequence may cause a small plateau to exist during the period.

The root cause of the plateau is related to the parasitic diodes in logic blocks which have multiple power sources. This leakage path is not a reliability concern for this device.
