TCI6638K2K

Multicore DSP+ARM KeyStone II SOC

Silicon Errata

Literature Number: SPRZ401F
June 2013–Revised May 2017

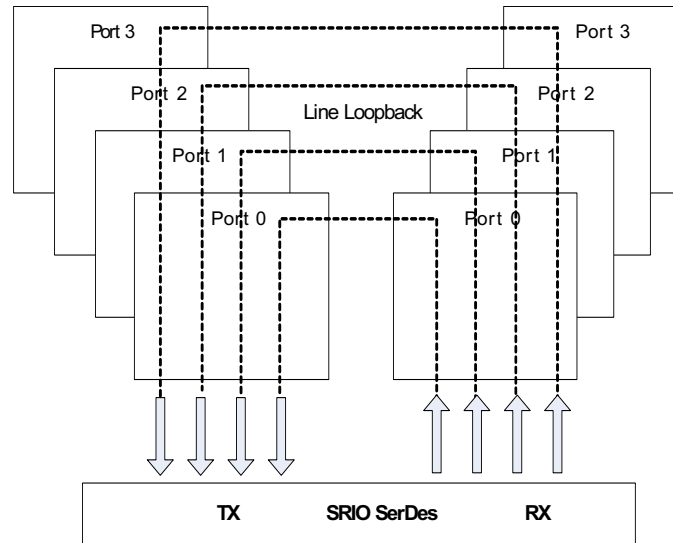
Figure 2. SRIO SerDes in Loopback Mode

The SRIO physical layer is configured in line-loopback mode on a per-port basis, by setting the LLB_EN bit in PLM_SP(n)_IMP_SPEC_CTL register. In line-loopback mode, the data from the SerDes receiver is looped back to the SerDes transmitter. [Figure 2](#) shows the line loopback from SerDes RX to SerDes TX.

The port does not provide any clock compensation when line loopback is enabled. The transmit clock must be externally synchronized with the receive clock. There is only a small FIFO that can compensate for PLL jitter or wander. Hence, correct operation of line loopback requires that the link partners use the same reference clock for the SRIO physical layer, in order to avoid overruns or underruns due to clock frequency mismatch between the link partners. As a result, line loopback mode is generally restricted to validation and qualification of board signal integrity in a lab environment.

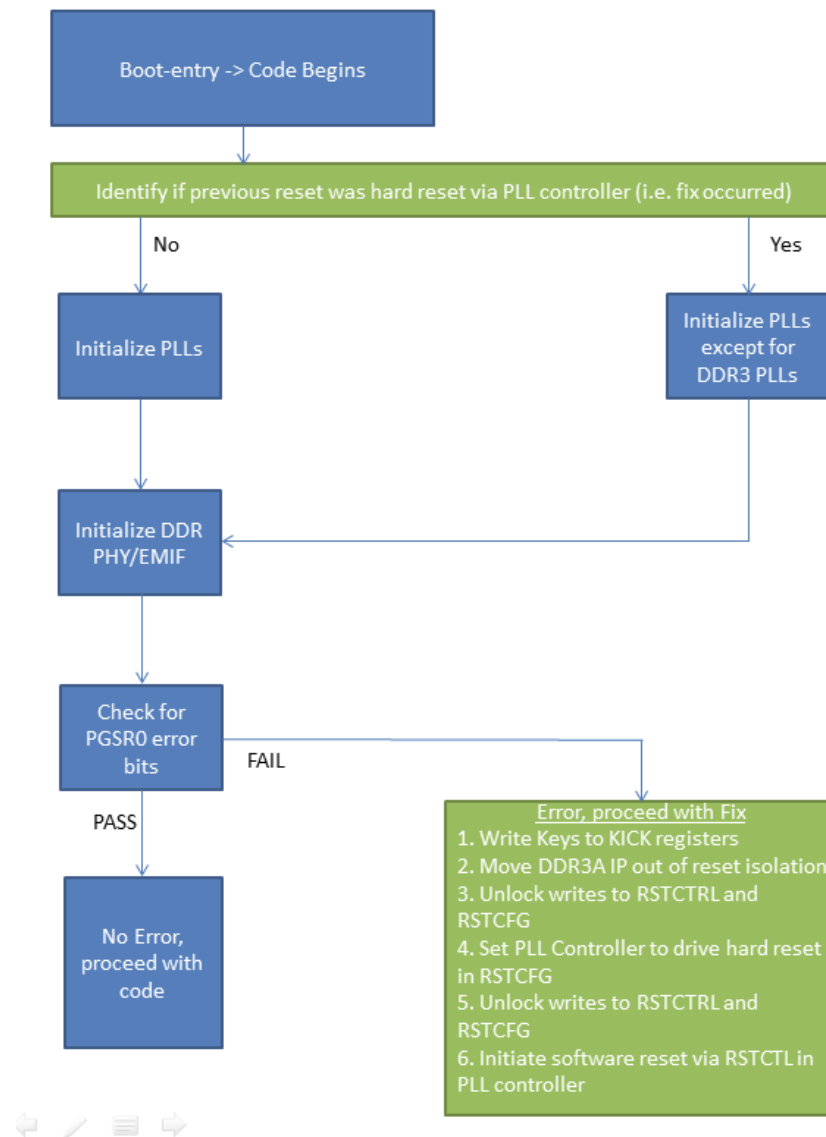
Figure 3. Software Reset Using the RSTCTRL Register

The root cause is identified to an issue that happens after the very first DDR3 PHY initialization, this first initialization happens directly from Power-on reset. The issue occurs because the clocking requirements of the DDR3 PHY are not met on the first initialization, this happens because the DDR3A and DDR3B SoC PLLs are not yet programmed to provide the requisite clock. There is a ratio requirement between the DDR3A/B PHY clocks and the core configuration clock, such that the core configuration clock must be less than or equal to the PHY clock. These clocks are asynchronous and the PHY support an asynchronous FIFO scheme with limited depth on the PHY clock domain. If the ratio requirement is not met then FIFO can overflow. This would mean that the configuration data for the PHY may be lost during the initialization sequence. Experiments have proven that if we apply Hard Reset once the clocking has been set up correctly, the issue is resolved.

BLUE colored blocks show the normal execution while the GREEN colored blocks show the changes. The “Error, proceed with Fix” block is the block which explains the steps that need to be followed to apply the Software Reset using RSTCTRL register. The steps are mentioned for DDR3A. The same steps need to be used for DDR3B also.

DDR read/write failures can be avoided by checking the DDR PHY status register for any Leveling errors at the end of DDR PHY Initialization. For boot modes using DDR, the workarounds below can be used as a part of second-stage boot only. Once the leveling errors are detected, one of the following workarounds can be used.

- *Software Reset using RSTCTRL register in PLL Controller*

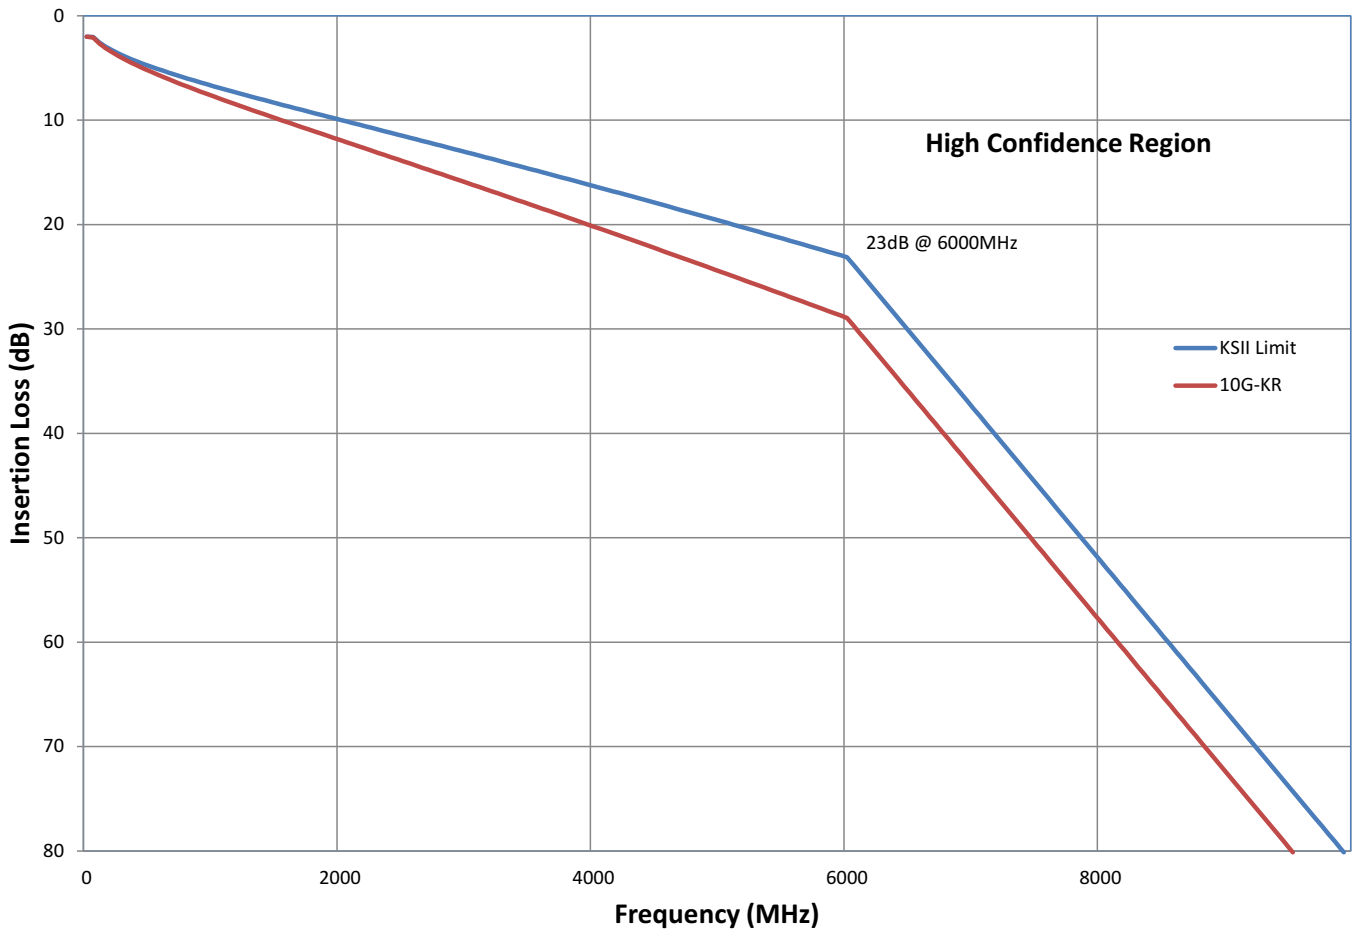
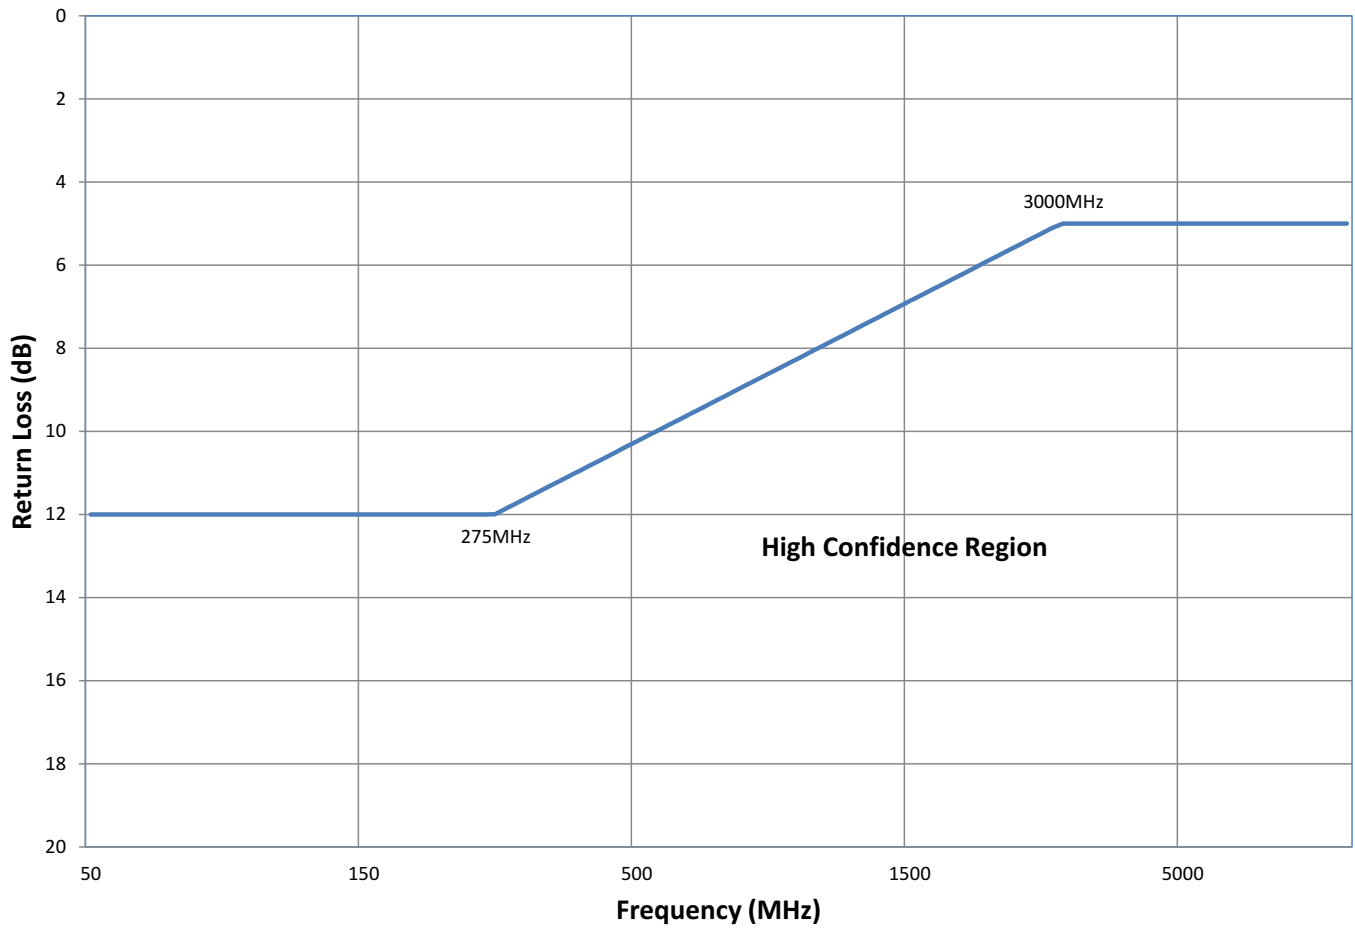
Device characterization has shown that bit error rate performance consistent with the 10GbE-KR standard as published in IEEE 802.3-2008 Annex 69B cannot be met across all device operating extremes. Production devices do operate at the required error rate across all rated operating conditions of voltage and temperature when the channel insertion loss is limited to 20dB at the Nyquist rate of 5.15625GHz. The figure below shows the Insertion Loss template from IEEE 802.3-2008 Annex 69B as well as the reduced Insertion Loss template.

Characterization has shown that channels must also be compliant with the Return Loss template contained in the IEEE 802.3-2008 Annex 69B specification without modification. This is shown below for convenience.

Workaround None.

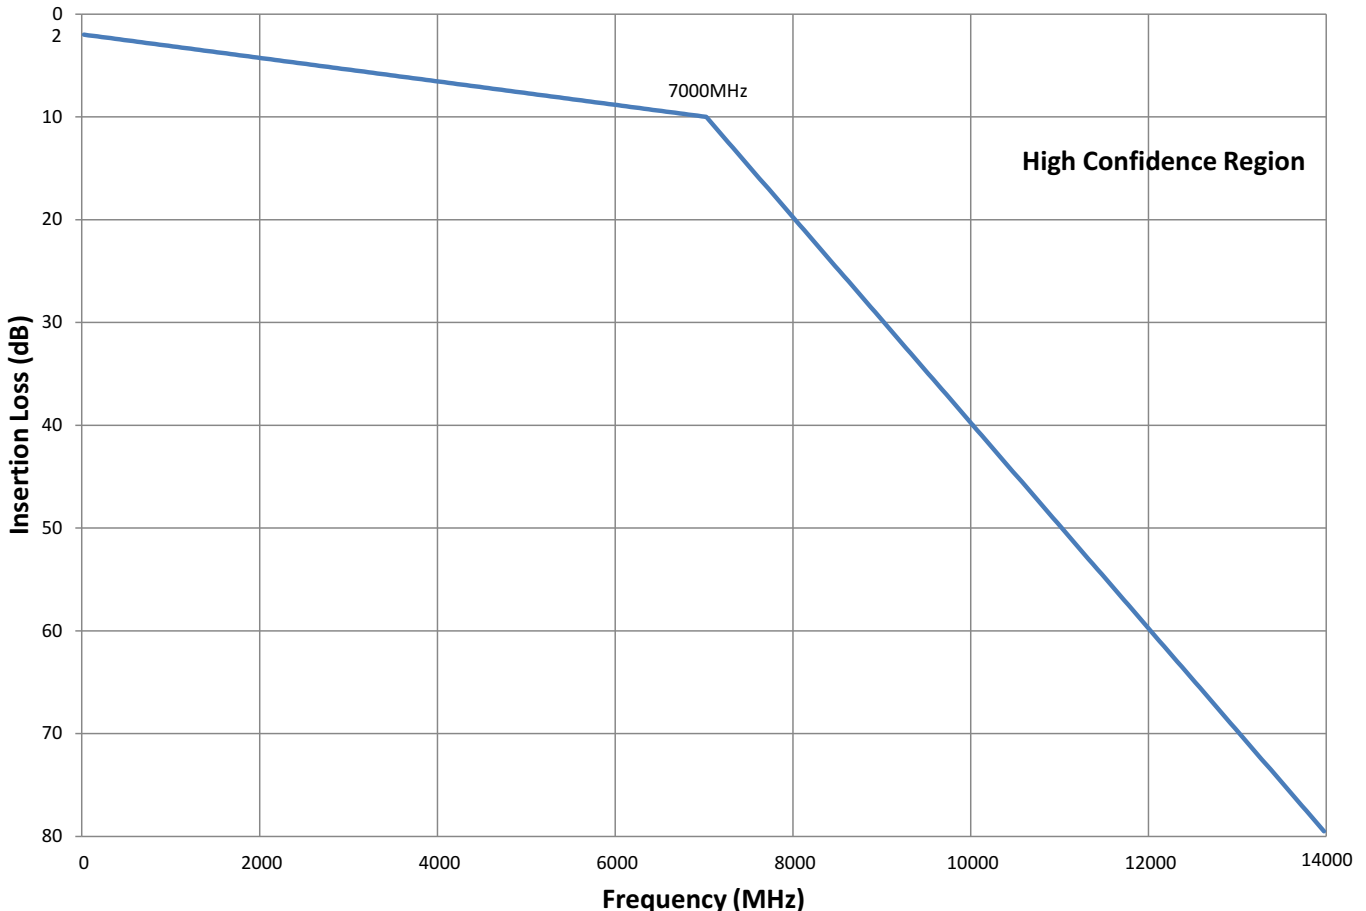
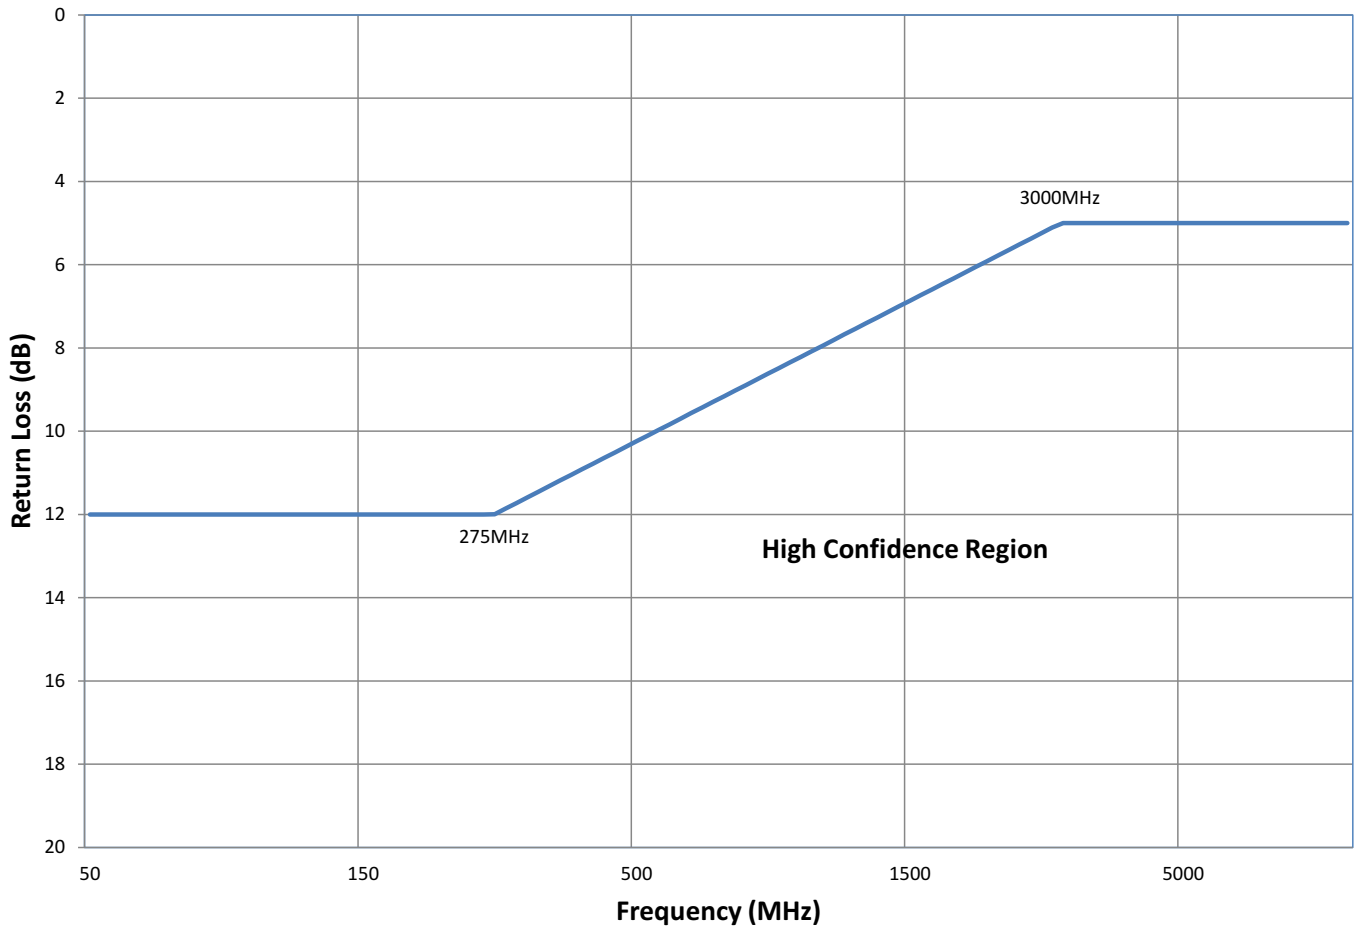
Device characterization has shown that expected bit error rate performance can only be met on layouts that meet constrained channel loss metrics. These can be examined by generating Insertion Loss and Return Loss graphs where loss is plotted versus frequency. Insertion Loss and Return Loss can be estimated during PCB layout using a 3D simulation tool. Insertion Loss and Return Loss should also be measured on early prototypes using a Vector Network Analyzer (VNA). Multiple PCB construction and layout enhancement techniques must be combined to achieve these channel performance requirements as stated in the KeyStone II SERDES User Guide.

An Insertion Loss measurement provides a composite view of the channel's loss versus frequency. Since HyperLink is a short-reach interface, channel loss is limited. Also, due to the high data rate, the Insertion Loss must be monotonic and without discontinuities that would degrade receiver operation. The template shown below provides Insertion Loss limits that will result in a robust channel. This template must be met for the entire channel from transmitter to receiver including the series capacitors.

Device characterization has also shown that channels should be compliant with the Return Loss template shown below. The Return Loss measurement indicates the amount of energy reflected back to the source which is not available to the receiver. Impedance variation in the channel will cause reflected energy that can cause this template to be violated. Careful attention to PCB construction and layout must be followed to meet this requirement. This template must be met for the entire channel from transmitter to receiver including the series capacitors. Note that this is the same template

defined in IEEE 802.3-2008 Annex 69B specification for 10GbE.

Workaround None.

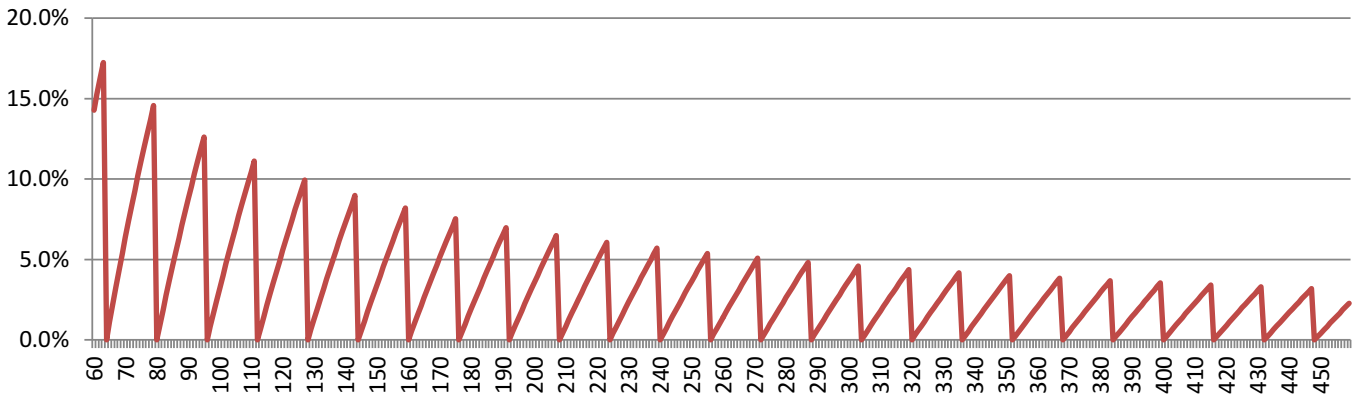
Figure 5. NSS Rate Limit Error % For Small Packets

$$\text{Rate error} = (((\text{FrameSize} \% 16) == 0) ? (16) : (\text{FrameSize} \% 16)) / (\text{FrameSize} + 24)$$

This results in the possibility of error rate as high as 10% with small packet sizes around 64 bytes that diminishes to less than 2% as packet sizes exceed 1K bytes. This can be seen in the graph below:

Workaround Since the rate-error is known, at least for fixed packet sizes, a software workaround can be implemented by calculating the “effective” packet-size to compensate for the calculation error in hardware. It is not possible to establish this workaround for streams with varying packet-sizes. It will only be meaningful when it is known that a port will mostly carry short length packets.

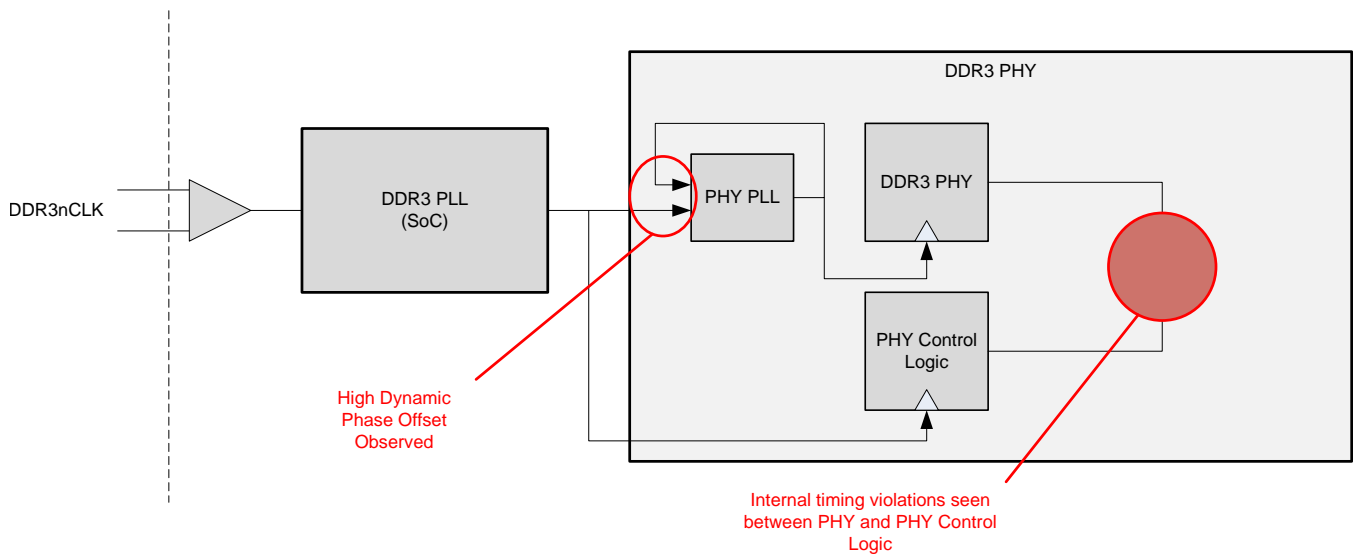
Figure 6. DDR3 PHY

DDR3 read operations may show errors due to increased levels of Dynamic Phase Offset (DPO) inside the DDR3 PHY. These errors are characterized by byte lane data corruption or intermittent bit errors. The byte lane data corruption can only be recovered using a device reset.

The DDR3 clocking architecture is illustrated in the figure below. The DDR3 reference clock input (DDR3nCLK) feeds the DDR3 SoC PLL, which outputs a clock to be used by the PHY Control Logic and provide an input to the PHY PLL.

The Dynamic Phase Offset (DPO) is a measure of the DDR3 PHY PLL’s ability to track rapid phase changes in the output of the DDR3 SoC PLL. High DPO can create internal timing violations between the DDR3 PHY and DDR3 PHY Control Logic and result in data errors during reads. As indicated by the shaded red circle in the figure above, the timing violations occur in the data transfer between the PHY and PHY control logic. It was determined that the root cause of the elevated DPO were SoC PLL and PHY PLL configurations that were non-optimized for the timing requirements of the system.

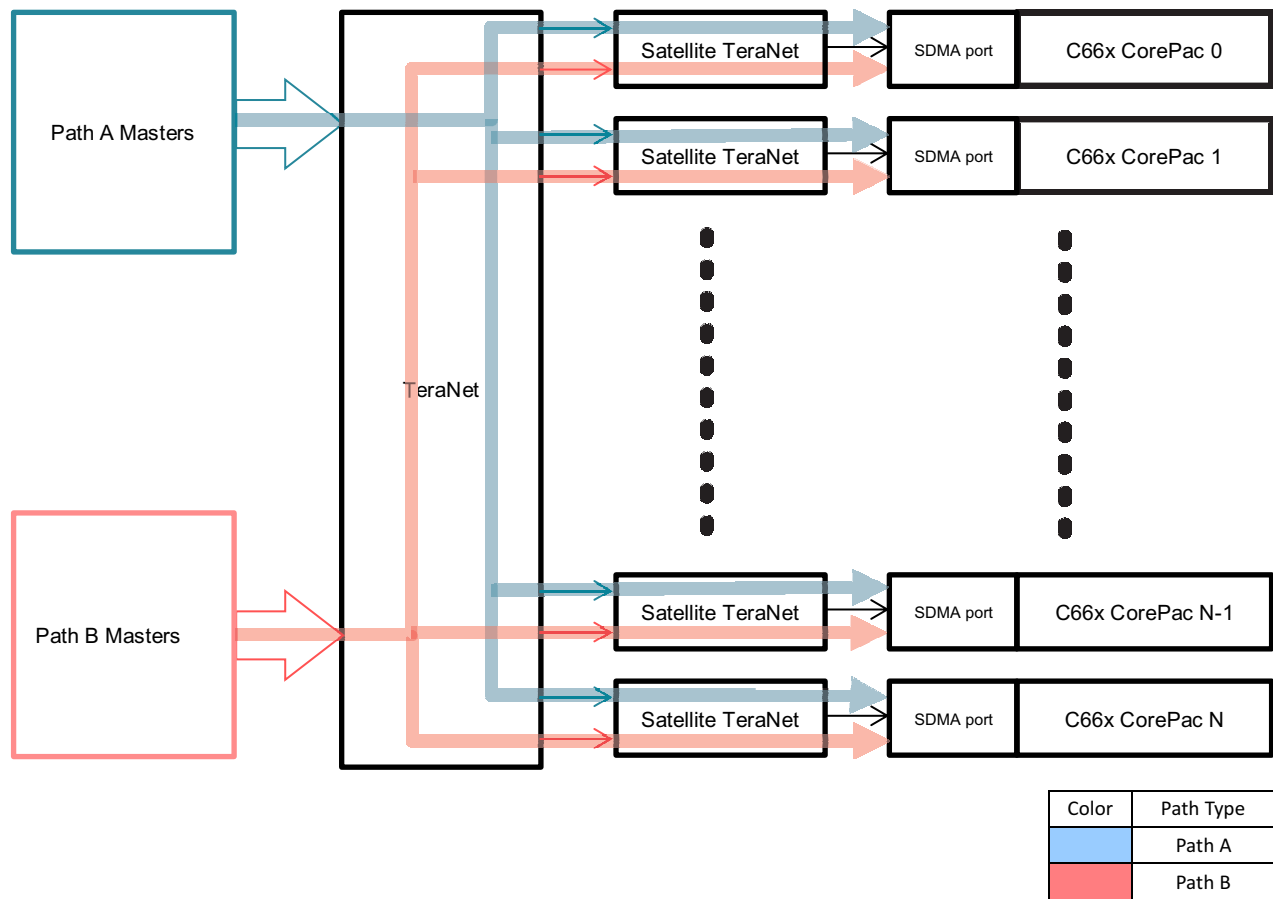
Figure 7. Satellite TeraNet Paths

When two masters send out write transactions to two C66x CorePac's L2 slave end points, a hang can occur when the C66x CorePacs are busy and stalling the incoming write transactions.

Each C66x CorePac has a TeraNet component in front of its slave (SDMA) port, which serves as a satellite TeraNet for C66x CorePac's SDMA port. Device masters communicate with the C66x CorePac's L2 memory through these satellite TeraNets. These satellite TeraNets have two input paths, path A and path B, and each path can be accessed by distinct set of masters. Thus, each write transaction appearing at the SDMA ports of C66x Corepac L2 memory can take one of the two possible paths, depending on the master that sent out that transaction.

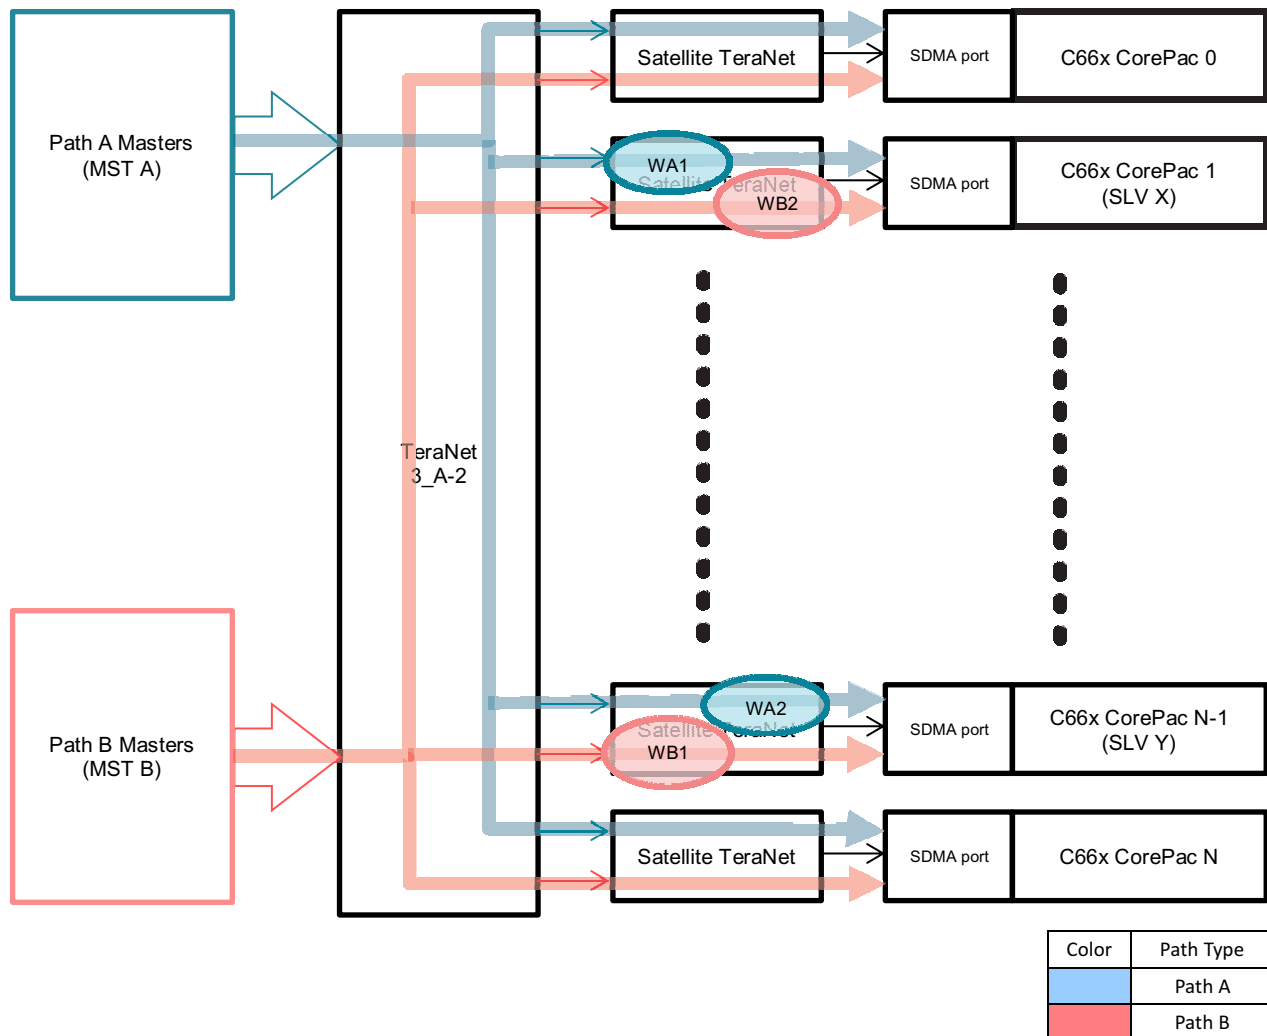
Figure 8. Hang Scenario

Hang Scenario: When a master (MST A) that uses path A and another master (MST B) that uses path B send out two writes each (WA1, WA2 and WB1, WB2) to two C66x CorePac slave end points (SLV X, SLV Y), a hang can occur if the following conditions occur:

- Both masters send one write to each of the two slave end points in opposite order:
 - MST A sends two writes: first write WA1 to SLV X, and second write WA2 to SLV Y
 - MST B sends two writes: first write WB1 to SLV Y, and second write WB2 to SLV X
- Writes from two masters arrive on separate paths at slave endpoint:
 - MST A writes arrive on path A
 - MST B writes arrive on path B
- Both slaves are busy, so they stall the incoming write transactions.
- Both slaves select second writes when they are ready:
 - SLV X selects WB2
 - SLV Y selects WA2

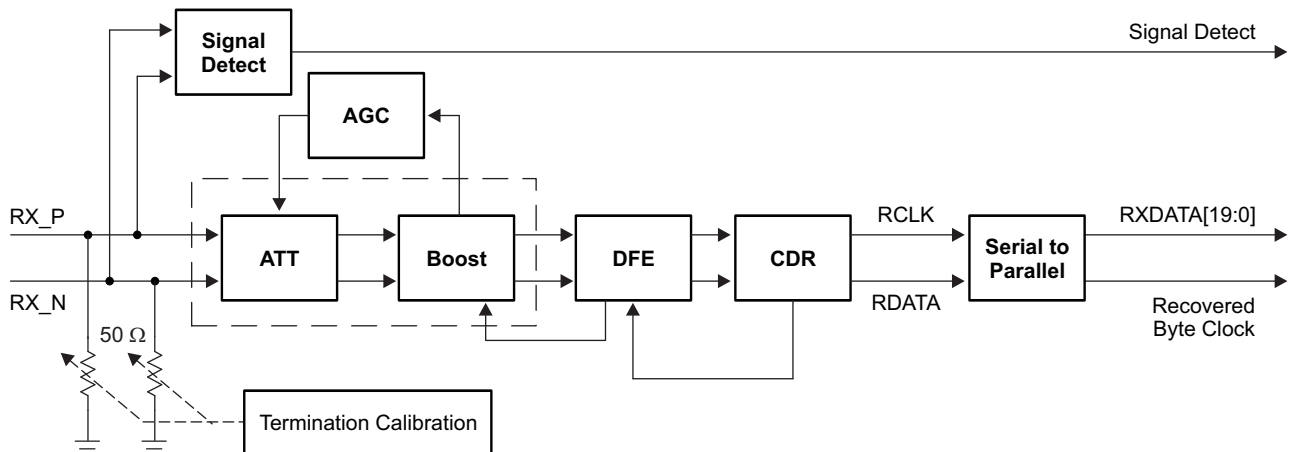
Figure 13. RX Path Block Diagram

Problem Summary: The SerDes on some peripherals will not automatically adapt its RX equalization when provided with certain data encodings common to that peripheral’s electrical standard.

Details The TI SerDes contains an adaptation algorithm that allows the RX equalization blocks to adapt their parameters to the SerDes data channel. The adaptation algorithm sets the optimal values for the ATT, BOOST, and DFE blocks in order to equalize the signal, maximize margin, and minimize channel distortion. For higher data rates (i.e. 5Gbps and greater), the high frequency gain provided by the BOOST block is generally considered necessary to compensate for the low-pass characteristics of data channels and widen the data eye.

The SerDes BOOST block was designed to require a specific set of patterns in order to best adapt its parameters to the channel. If these patterns are not found, the BOOST adaptation algorithm will not update the internal block settings and/or may incorrectly update these settings. The required data pattern is a series of six 0's followed by a 101 pattern. This pattern must occur numerous times on both odd and even bit alignments. This data pattern is not present in the 8b/10b coded symbols that are sent over many of the high speed peripheral links.
