Stellaris® LM4F Microcontrollers Silicon Revisions 6 and 7

Silicon Errata

Literature Number: SPMZ856C
September 2013–Revised February 2014

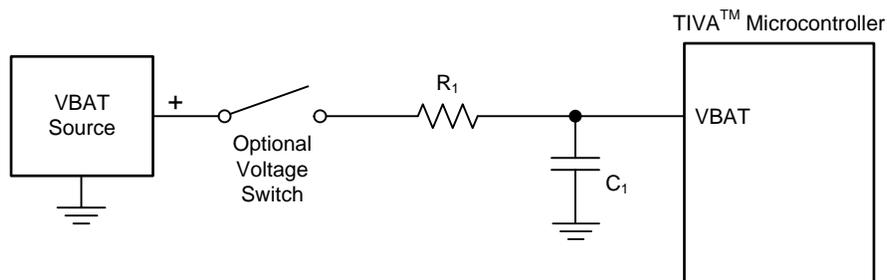
Figure 2. RC Circuit

Description The V_{BAT} supply pin may be damaged if the pin voltage ramps faster than 0.7 V/ μ s. Fast V_{BAT} ramps are a concern when a battery is being connected or the V_{BAT} supply is hard switched.

Workaround(s) An RC circuit as shown should be added to the V_{BAT} pin to prevent the damage. The R_1 and C_1 should be placed close to the microcontroller for best protection. In systems that do not require Hibernate when the VDD supply is off, the V_{BAT} pin should be tied to the VDD supply, which typically ramps at a rate slower than 0.7 V/ μ s. The R_1 and C_1 components are not required for a V_{BAT} supply ramp less than 0.7 V/ μ s.
