MSP430F1121A Device Erratasheet

1 Functional Errata Revision History

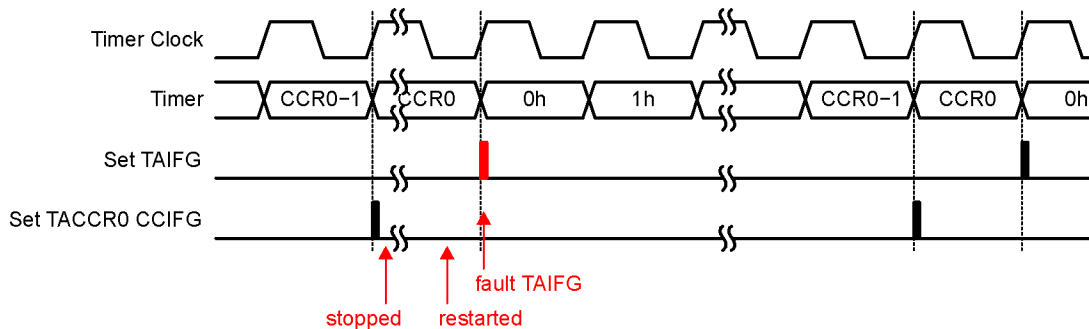
TA21 *TIMER_A Module*

Function TAIFG Flag is erroneously set after Timer A restarts in Up Mode

Description In Up Mode, the TAIFG flag should only be set when the timer counts from TACCR0 to zero. However, if the Timer A is stopped at TAR = TACCR0, then cleared (TAR=0) by setting the TACLRL bit, and finally restarted in Up Mode, the next rising edge of the TACLK will erroneously set the TAIFG flag.

Workaround None.
