# MSP430F4619 Device Erratasheet

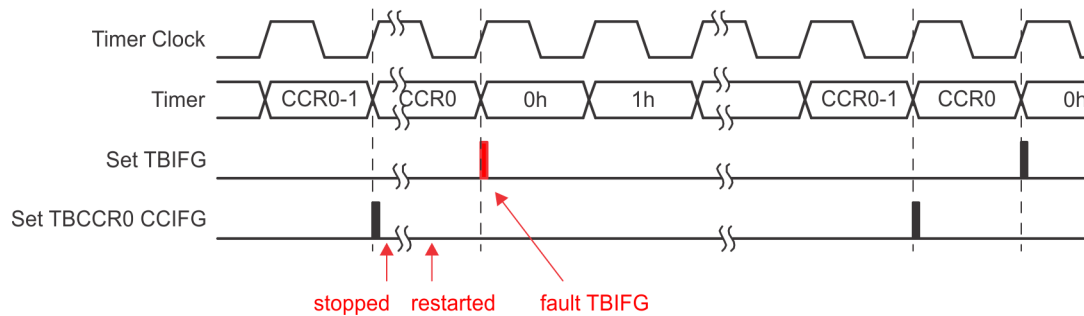
<b>TB24</b>	<b><i>TIMER_B Module</i></b>
<b>Category</b>	Functional
<b>Function</b>	TBIFG Flag is erroneously set after Timer B restarts in Up Mode
<b>Description</b>	In Up Mode, the TBIFG flag should only be set when the timer resets from TBCCR0 to zero. However, if the Timer B is stopped at TBR = TBCCR0, then cleared (TBR=0) by

setting the TBCLR bit, and finally restarted in Up Mode, the next rising edge of the TBCLK will erroneously set the TBIFG flag.

None.
