MSP430F5502 Device Erratasheet

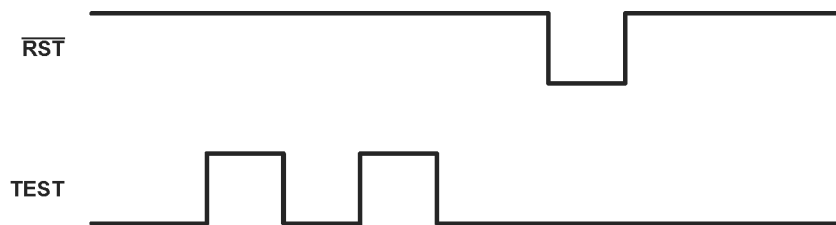
Category	Software in ROM
Function	BSL does not exit to application code
Description	The methods used to exit the BSL per MSP430 Programming Via the Bootstrap Loader (SLAU319) are invalid.
Workaround	To exit the BSL one of the following methods must be used. - A Power cycle or - Toggle the TEST pin twice when nRST is high and after 50us pull nRST low.

Note: This toggling of TEST pins is not subject to timing constraints. The appropriate level transitions on TEST pin, followed by a RST pulse after 50us, are sufficient to trigger an exit from BSL mode.
