MSP430F5503 Device Erratasheet

The revision of the device can be identified by the revision letter on the [Package Markings](#) or by the [HW_ID](#) located inside the TLV structure of the device

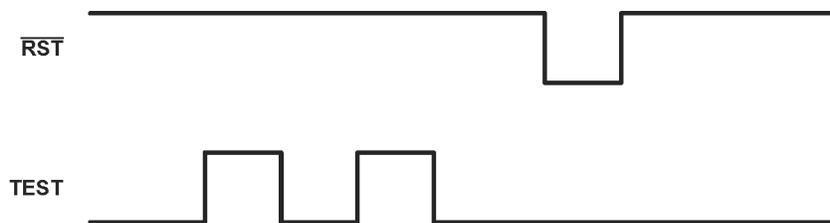
| Description | The methods used to exit the BSL per MSP430 Programming Via the Bootstrap Loader (SLAU319) are invalid. |

| Workaround | To exit the BSL one of the following methods must be used. - A Power cycle or - Toggle the TEST pin twice when nRST is high and after 50us pull nRST low. |

Note: This toggling of TEST pins is not subject to timing constraints. The appropriate level transitions on TEST pin, followed by a RST pulse after 50us, are sufficient to trigger an exit from BSL mode.
