MSP430F5515 Device Erratasheet

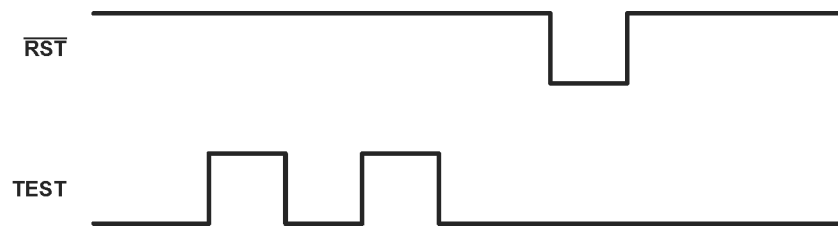
The methods used to exit the BSL per MSP430 Programming Via the Bootstrap Loader ([SLAU319](#)) are invalid.

- Workaround** To exit the BSL one of the following methods must be used.
- A Power cycle
- or
- Toggle the TEST pin twice when nRST is high and after 50us pull nRST low.

Note: This toggling of TEST pins is not subject to timing constraints. The appropriate level transitions on TEST pin, followed by a RST pulse after 50us, are sufficient to trigger an exit from BSL mode.

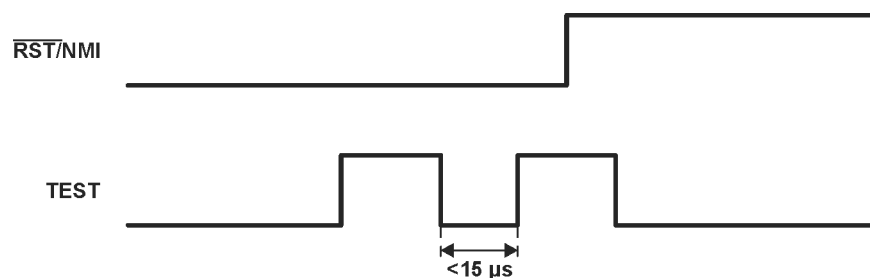
The BSL entry sequence requires that the low phase of the TEST/SBWTCK pin does not exceed 15us. This timing requirement is faster than most PC serial ports can provide, as shown in the following picture. If this requirement is not met, the entry sequence fails and the SYSBSLIND is not set.

An external hardware solution is recommended to provide the appropriate BSL entry sequence. See [http://processors.wiki.ti.com/index.php/BSL_\(MSP430\)](http://processors.wiki.ti.com/index.php/BSL_(MSP430)) for recommendations on available BSL hardware.
