MSP430F5521 Device Erratasheet

The revision of the device can be identified by the revision letter on the [Package Markings](#) or by the [HW_ID](#) located inside the TLV structure of the device

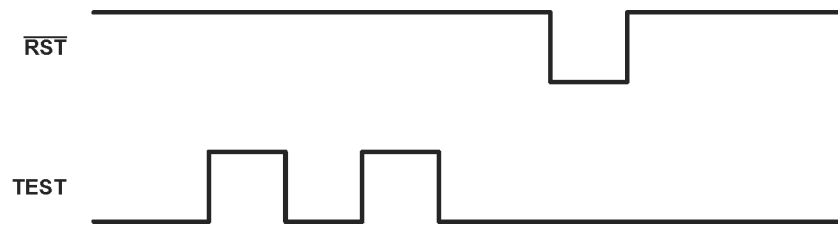
JTAG20
JTAG Module

Category	Software in ROM
Function	BSL does not exit to application code
Description	The methods used to exit the BSL per MSP430 Programming Via the Bootstrap Loader (SLAU319) are invalid.
Workaround	To exit the BSL one of the following methods must be used. - A Power cycle or - Toggle the TEST pin twice when nRST is high and after 50us pull nRST low.

Note: This toggling of TEST pins is not subject to timing constraints. The appropriate level transitions on TEST pin, followed by a RST pulse after 50us, are sufficient to trigger an exit from BSL mode.

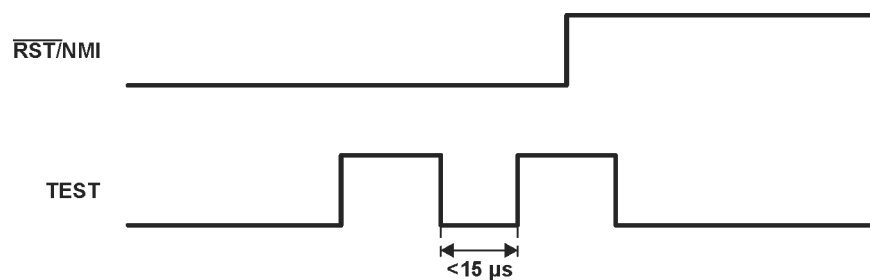
The BSL entry sequence requires that the low phase of the TEST/SBWTCK pin does not exceed 15us. This timing requirement is faster than most PC serial ports can provide, as shown in the following picture. If this requirement is not met, the entry sequence fails and the SYSBSLIND is not set.

An external hardware solution is recommended to provide the appropriate BSL entry sequence. See [http://processors.wiki.ti.com/index.php/BSL_\(MSP430\)](http://processors.wiki.ti.com/index.php/BSL_(MSP430)) for recommendations on available BSL hardware.

Note: The erroneous behavior is only applicable if the default TI USB BSL is replaced by the TI UART BSL.
