## MSP430FG4618 Device Erratasheet

### 1 Functional Errata Revision History

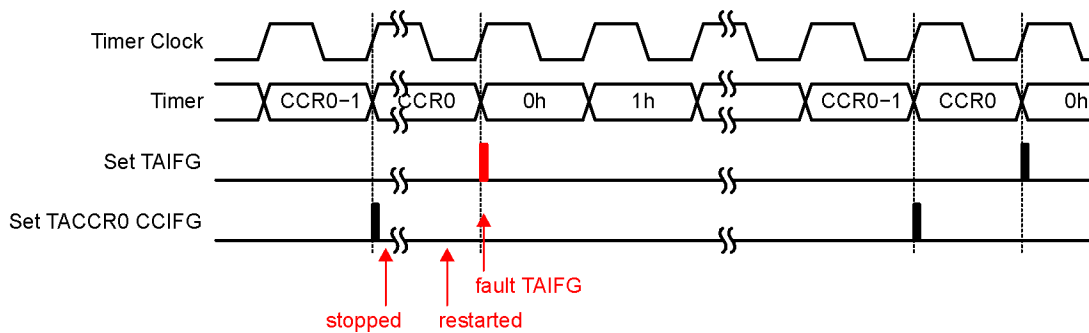
**TA21**

TAIFG Flag is erroneously set after Timer A restarts in Up Mode

In Up Mode, the TAIFG flag should only be set when the timer counts from TACCR0 to zero. However, if the Timer A is stopped at TAR = TACCR0, then cleared (TAR=0) by setting the TACLK bit, and finally restarted in Up Mode, the next rising edge of the TACLK will erroneously set the TAIFG flag.

**Workaround**

None.
