# MSP430FG479 Device Erratasheet

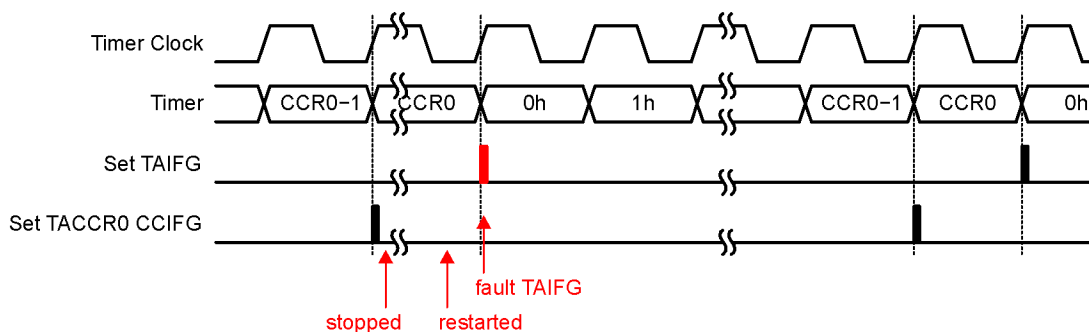
**TA21** *TIMER\_A Module*

**Function** TAIFG Flag is erroneously set after Timer A restarts in Up Mode

**Description** In Up Mode, the TAIFG flag should only be set when the timer counts from TACCR0 to zero. However, if the Timer A is stopped at TAR = TACCR0, then cleared (TAR=0) by setting the TACLR bit, and finally restarted in Up Mode, the next rising edge of the TACLK will erroneously set the TAIFG flag.

**Workaround** None.
