MSP430G2432 Device Erratasheet

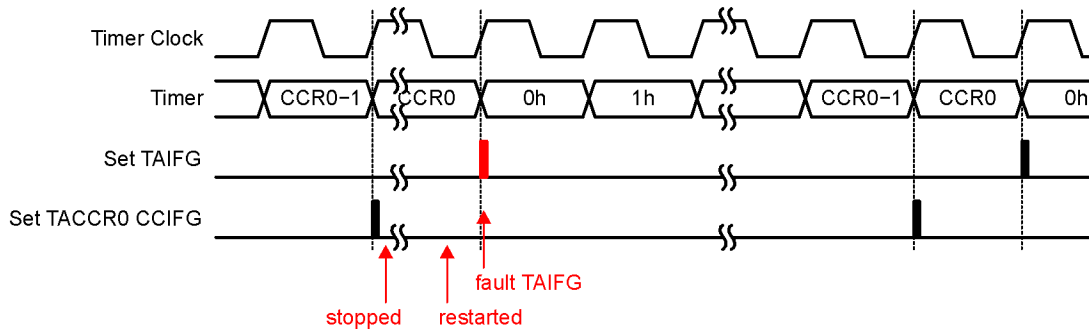
TA21 *TIMER_A Module*

Function TAIFG Flag is erroneously set after Timer A restarts in Up Mode

Description In Up Mode, the TAIFG flag should only be set when the timer counts from TACCR0 to zero. However, if the Timer A is stopped at TAR = TACCR0, then cleared (TAR=0) by setting the TACLR bit, and finally restarted in Up Mode, the next rising edge of the TACLK will erroneously set the TAIFG flag.

Workaround None.
