# **TMS320F280x, TMS320C280x, TMS320F2801x DSPs Silicon Revisions C, B, A, 0**

## **1 Introduction**

This document describes the silicon updates to the functional specifications for the TMS320F2809, TMS320F2808, TMS320F2806, TMS320F2802, TMS320F2801, TMS320C2802, TMS320C2801, TMS320F28016, and TMS320F28015 digital signal processors (DSPs).

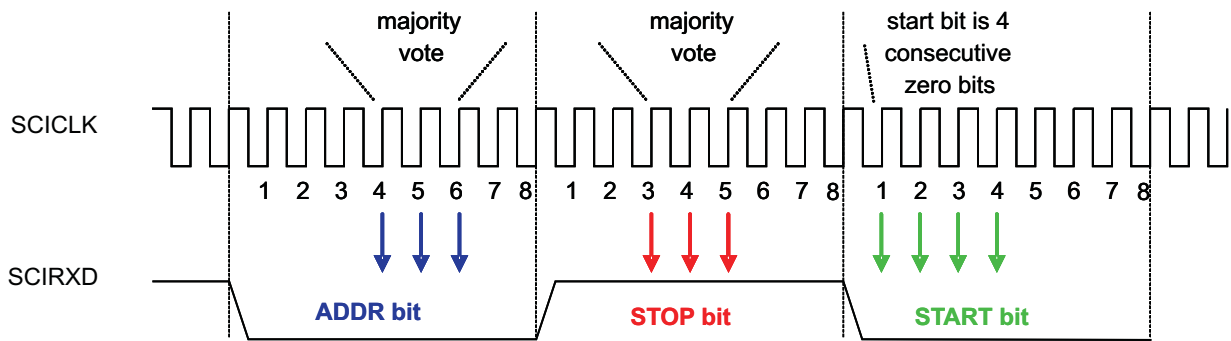
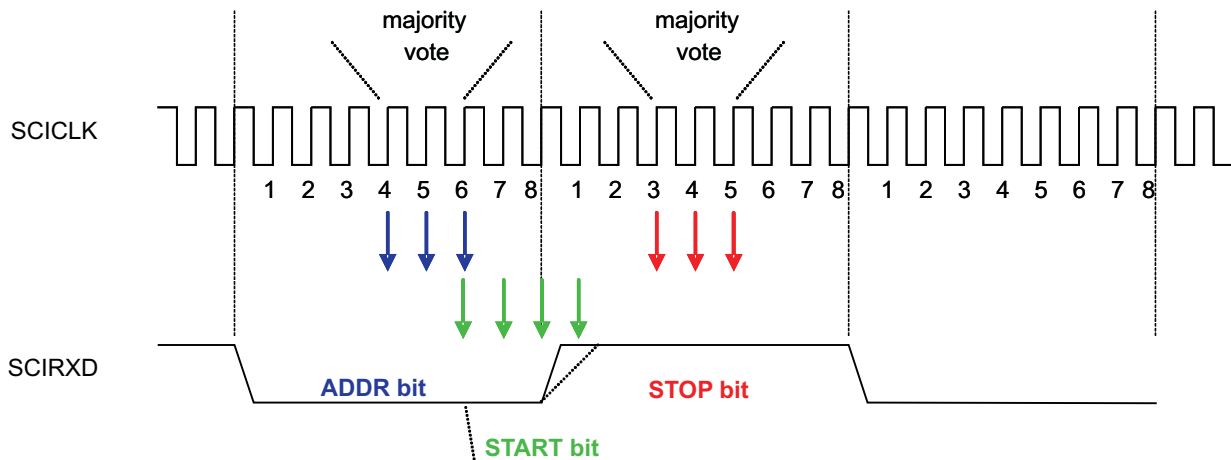
**Figure 3. Difference Between Expected and Erroneous Operation of START Bit**

**Advisory** *SCI: Incorrect Operation of SCI in Address Bit Mode*

**Details** SCI does not look for STOP bit after the ADDR bit. Instead, SCI starts looking for the start bit beginning on sub-sample 6 of the ADDR bit. Slow rise-time from ADDR to STOP bit can cause the false START bit to occur since the 4th sub-sample for the start bit may be sensed low.

**Workaround(s)** Program the baud rate of the SCI to be slightly slower than the actual. This will cause the 4th sub-sample of the false START bit to be delayed in time, and therefore occur more towards the middle of the STOP bit (away from the signal transition region). The amount of baud slowing needed depends on the rise-time of the signal in the system. Alternatively, IDLE mode of the SCI module may be used, if applicable.
