TMS320F281x DSPs

Silicon Revisions G, F, E, D, C, B, A, 0

This document describes the silicon updates to the functional specifications for the TMS320F2810, TMS320F2811, and TMS320F2812 digital signal processors (DSPs).

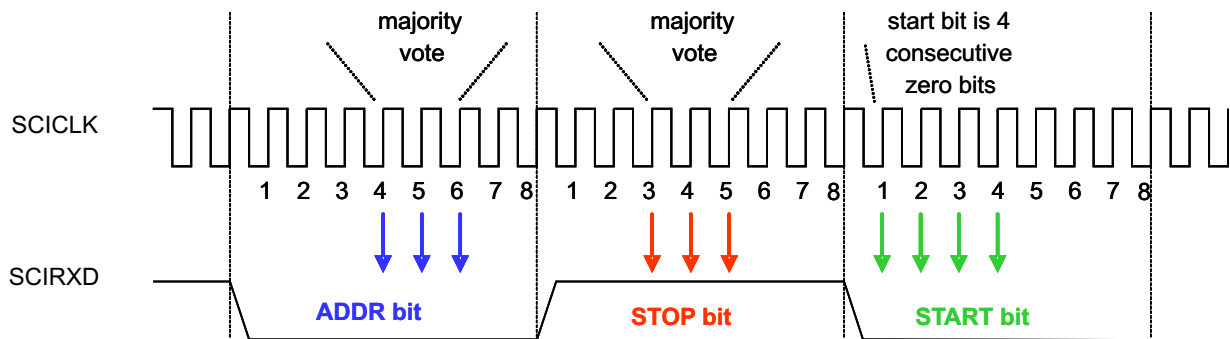
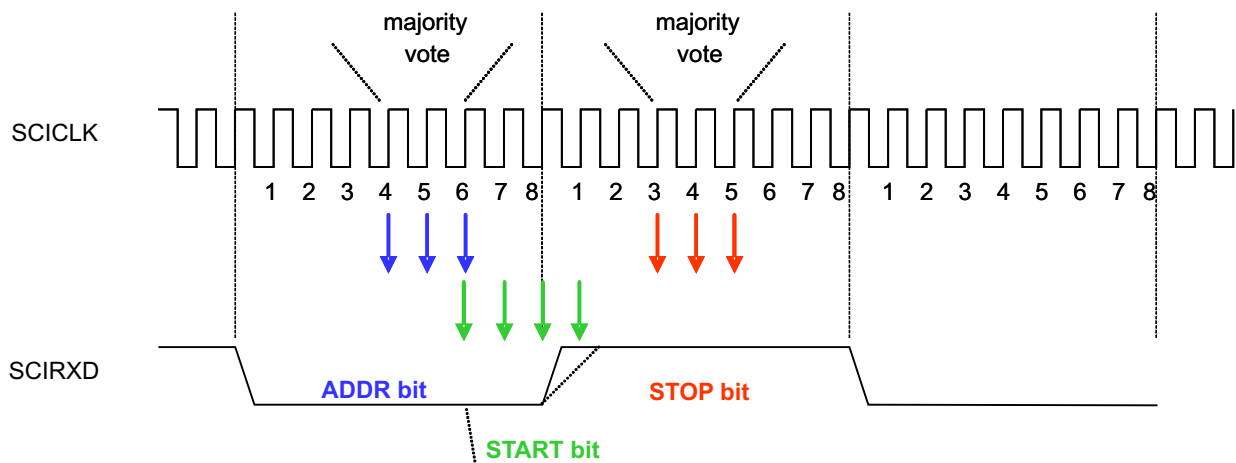
Figure 3. Difference Between Expected and Erroneous Operation of START Bit

Advisory **SCI: Incorrect Operation of SCI in Address Bit Mode**
Revision(s) Affected 0, A, B, C, D, E, F and G

Details The SCI does not look for the STOP bit after the ADDR bit. Instead, the SCI starts looking for the start bit beginning on sub-sample 6 of the ADDR bit. Slow rise time from the ADDR bit to the STOP bit can cause a false START bit to occur since the 4th sub-sample for the start bit may be sensed low.

Workaround(s) Program the baud rate of the SCI to be slightly slower than the actual. This will cause the 4th sub-sample of the false START bit to be delayed in time, and therefore occur more towards the middle of the STOP bit (away from the signal transition region). The amount of baud-slowng needed depends on the rise time of the signal in the system. Alternatively, the IDLE mode of the SCI module may be used, if applicable.
