AM437x Sitara™ Processors

Silicon Revisions 1.1, 1.2

1 Introduction

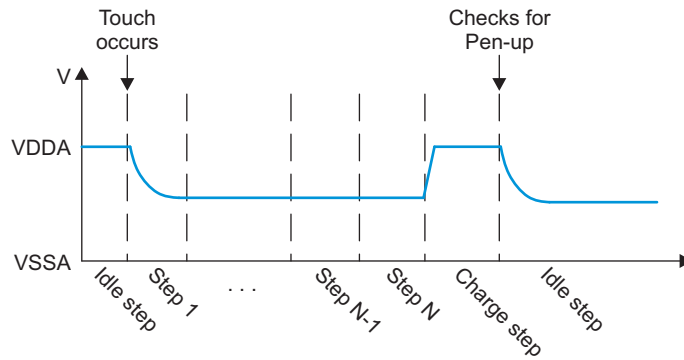
Figure 5. TSC Generates False Pen-up Interrupt

Details The touchscreen controller (TSC) determines the pen state (up or down) by checking the respective analog input (AIN0 for 4-wire or AIN4 for 5-wire) voltage level immediately after the Charge step. This does not provide enough time for the analog input voltage to return to the normal Pen-down voltage before testing the pen state. This will cause the TSC to generate a false Pen-up interrupt if the Charge step is enabled with the strong pull-up turned on when using hardware synchronized steps. Figure 5 illustrates the effect on the analog voltage when constant pen pressure is applied to the touchscreen and held through the Charge step.

- The first workaround is implemented by configuring the Charge step exactly like the Idle step, where the internal strong pull-up is not turned on. This workaround will remove the strong pull-up on the analog input during the Charge step and leave only the internal weak pull-up. The weak pull-up is not strong enough to effect the normal Pen-down voltage. Therefore, the voltage applied to the analog input will not rise and cause the TSC to generate a false Pen-up interrupt. There is a drawback to this approach; this workaround will cause the Pen-down event to remain active until the weak pull-up turned on in the Idle step charges the touchscreen capacitance, as shown in Figure 6.
