AM571x (SR 2.0, 1.0) and AM570x (SR 2.1, 2.0) Sitara™ Processors

1 Introduction

This document describes the known exceptions to the functional specifications for the device.

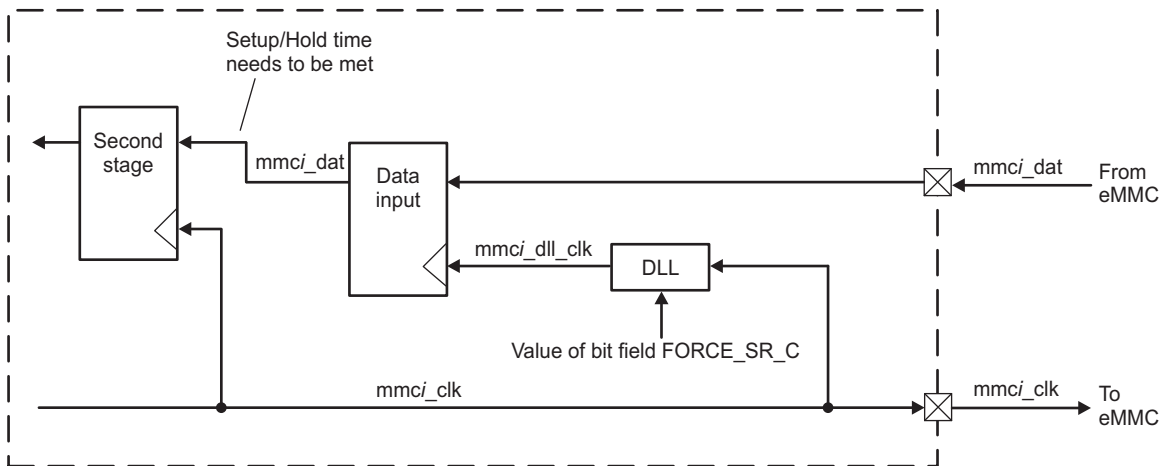
Figure 1. Simplified SoC 192-MHz Mode DLL Block Diagram

DESCRIPTION Internal to the MMC module, a second stage latch is used to recapture data captured by DLL delayed clock, *mmci_dll_clk*. The second stage latch captures with the original transmitting clock, *mmci_clk*.

mmci_dll_clk and *mmci_clk* both run at the same clock frequency. This results in a narrow range of tuning ratio elements, where the delayed *mmci_dll_clk* comes in phase with *mmci_clk*. If the clocks are in phase, the data captured by the first clock violates the setup and hold time requirements needed for the second stage latch, resulting in incorrectly read data. This is known as tuning re-timing errors.

For systems in which MMC DLL tuning algorithm* chooses a ratio less than 40, which is sufficiently far from the lowest re-timing error ratio element, no workaround is necessary.

WORKAROUND A DLL tuning algorithm has been implemented that can avoid the tuning re-timing errors. More details on this can be found in App Note [SPRACA9](#). The following notes summarize the updated algorithm:
