66AK2G0x Multicore DSP+ARM KeyStone II System-on-Chip (SoC) Silicon Revision 1.0

This document describes the known exceptions to the functional specifications (advisories). This document may also contain usage notes. Usage notes describe situations where the device's behavior may not match presumed or documented behavior. This may include behaviors that affect device performance or functional correctness.

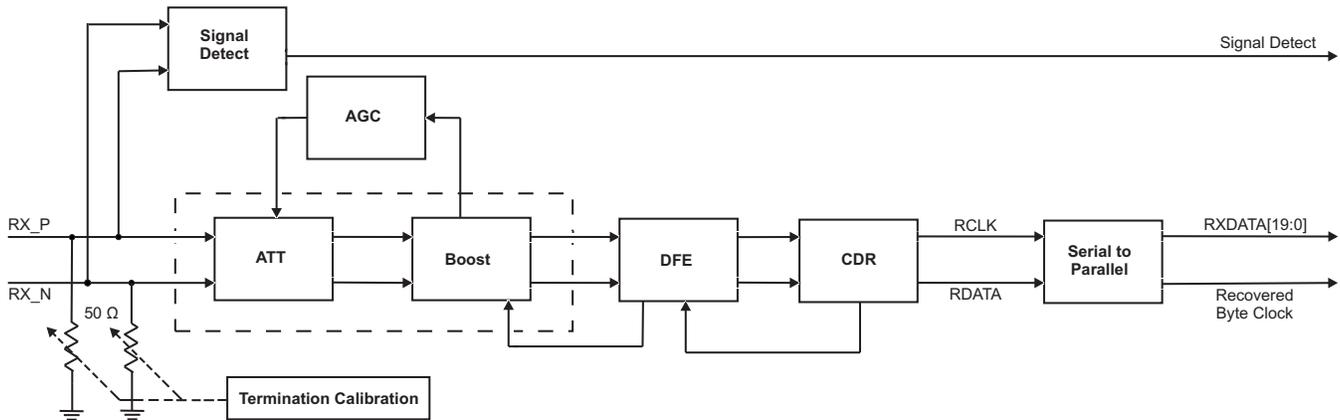
Figure 2. RX Path Block Diagram

The SerDes on PCIe will not automatically adapt its RX equalization when provided with certain data encodings common to that peripheral's electrical standard.

The SerDes BOOST block was designed to require a specific set of patterns in order to best adapt its parameters to the channel. If these patterns are not found, the BOOST adaptation algorithm will not update the internal block settings and/or may incorrectly update these settings. The required data pattern is a series of six 0's followed by a 101 pattern. This pattern must occur numerous times on both odd and even bit alignments. This data pattern is not present in the 8b/10b coded symbols that are sent over many of the high speed peripheral links.

If the BOOST has not been properly adapted for the received signal, then there is a chance that the SerDes will be unable to recover the RX data or the error rate may be higher than expected.

The recommended workaround is to not use the RX equalization auto-adaptation mechanism with the impacted interfaces at higher data rates. As an alternative, a user can hardcode the optimal ATT and BOOST values for their channel. These optimal ATT and BOOST values must be determined by the user through one of two options:

The optimal ATT and BOOST values found by one of the two above methods can be hardcoded into the SerDes upon initialization.

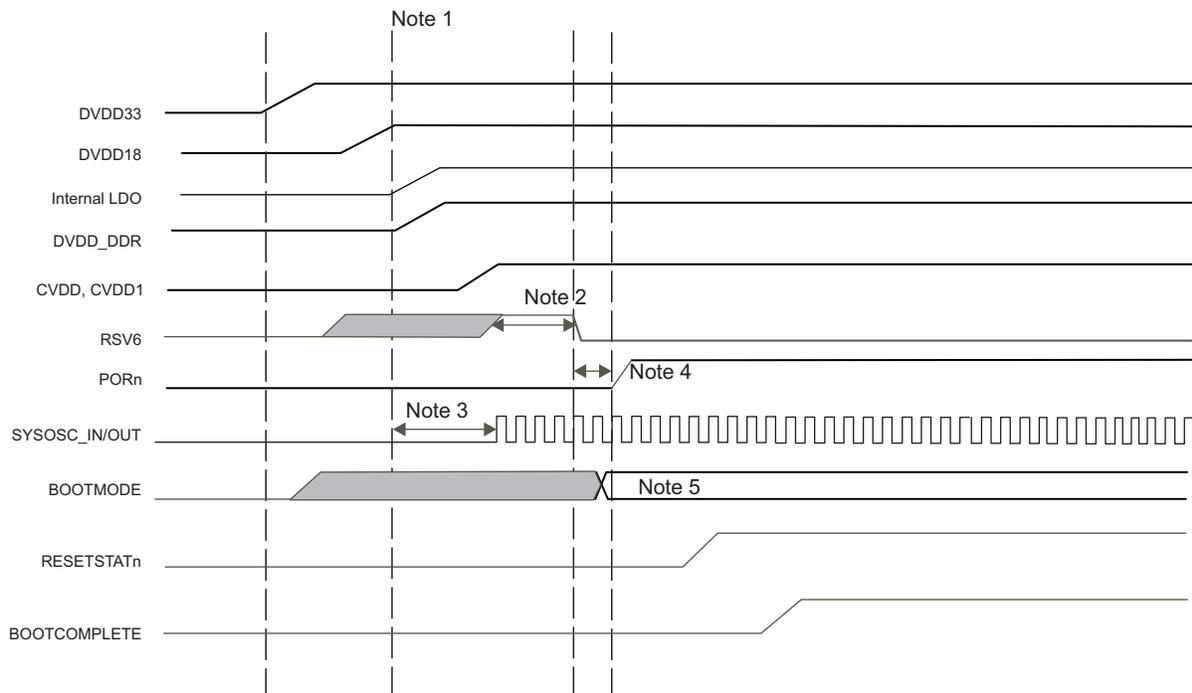
Figure 3. Power System Sequence when SYSCLKSEL is Low

Details: The default state of the internal HF Oscillator is not always set correctly. If this condition occurs, the internal HF Oscillator will not start causing the SoC to remain in the reset state.

This issue is only observed if the SYSCLKSEL is set low to select the internal HF OSC. If the problem occurs, no oscillation will be observed at the SYSOSC_OUT pin and the part will not exit reset. JTAG access will not be possible either.

Workaround(s): This state can be avoided by setting RSV6 to a high state while PORn is low for a minimum of 5msec after the power supplies are stable. Setting the RSV6 high will cause the HF OSC to initialize correctly allowing it to oscillate. RSV6 must then be set low a minimum of 1msec before PORn is set high. From that time on, RSV6 must be held low for proper operation.

- Note 1 – Power-up begins by enabling the DVDD33 supply first.
- Note 2 – Once DVDD33 is present, RSV6 is set high and must remain high for 5msec after all supplies have ramped.
- Note 3 – Oscillator Power-up time once DVDD18 is present and RSV6 is high (approx. 1-2msec).
- Note 4 – PORn must be held low until all supplies have ramped and for a minimum of 1msec after RSV6 is brought low. RSV6 must remain low after PORn is set high.
- Note 5 – BOOTMODE pins are latched at the rising edge of PORn (synchronously using SYSOSC_IN/OUT).
