Flash Read Error and Susceptibility for MSP430F55xx

MSP430

This document provides a description of the issue referred to as “Flash Read Error” impacting the current version of the MSP430F55xx device derivatives. It also provides guidance in assessing whether and the extent to which the issue may affect a given application. Specific actions and customer recommendations are set forth in the [PCN #20100910003A](#).

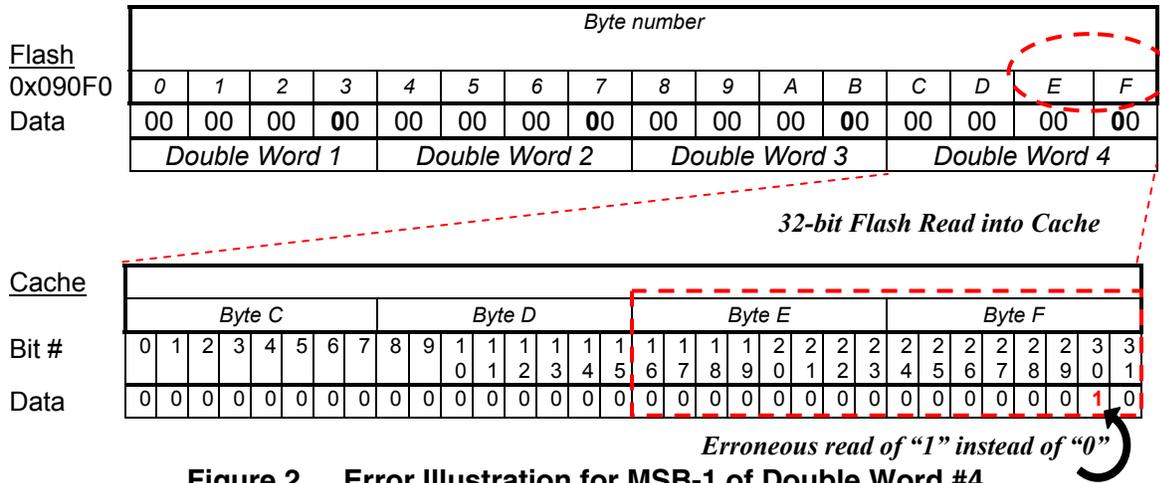
Figure 2. Error Illustration for MSB-1 of Double Word #4

Example: This illustration considers 16 bytes of flash data starting at address 0x090F0 and all contain the value 0x00. A CPU instruction execution triggers an access of the Flash word (at 0x090FE) and saves it to CPU register R5:

Instruction: `mov.w &0x090FEh, R5`

Result: Valid: R5= 0000h
Invalid: R5= 4000h

The read operation by the CPU of address 0x090FE will actually trigger the reading of double word #4 from flash (data from 0x090FC to 0x090FF), which is then stored into the 32-bit cache. The uppermost two bytes (0x090FE and 0x090FF) make up the 16-bit word located at 0x090FE. The result of the read in the case of a flash read error is an invalid readout of the MSB-1 for the given double word access. Instead of the expected logic "0", a logic "1" may be erroneously read out and stored in the cache for CPU computation: 0x4000 is erroneously read out and moved to R5 instead of 0x0000. This potential error applies to the MSB-1 for each double word as indicated by the bold "0"s in Figure 2 at each 4th byte.

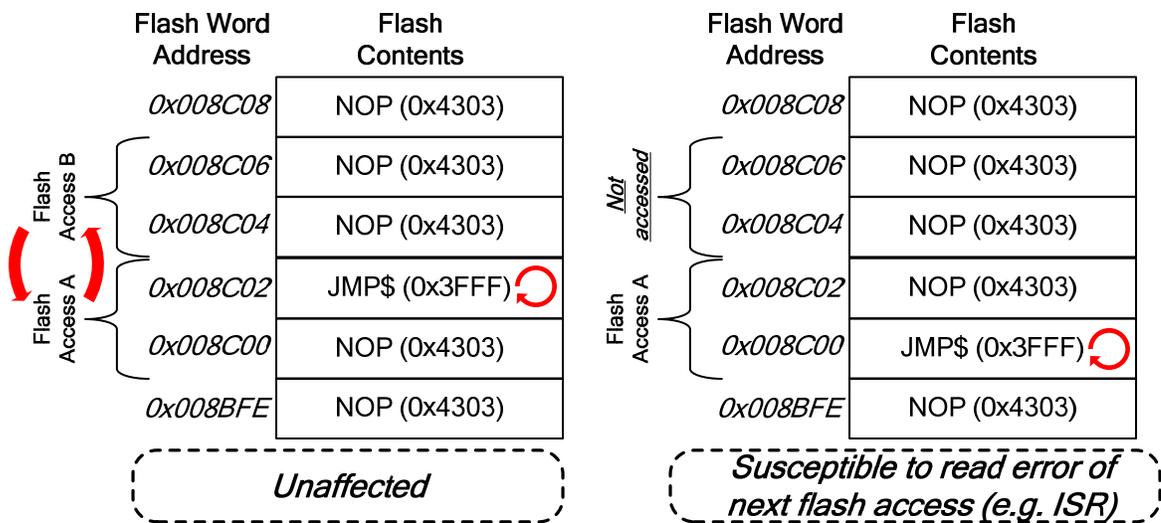
Figure 3. JMP\$ Alignment and Read Error Behavior

Figure 3 shows the relationship of the JMP\$ instruction position in memory and the behavior of the Flash access. On the right, the JMP\$ is at the lower word of the double word fetched from flash. This placement results in the CPU being able to execute entirely from the cached double word containing the JMP\$ instruction which stops flash access activity.

When the JMP\$ instruction resides in the upper word of the double word memory fetch, as shown in the left portion of Figure 3, the cache continuously alternates between flash accesses A and B which keeps the flash access constant.

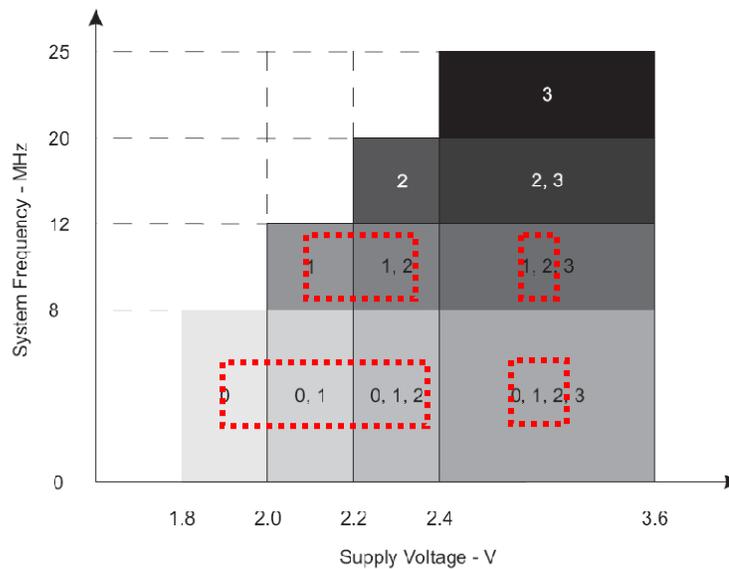
Figure 4. Core Voltage Settings With Reduced Susceptibility

The Vcore settings 0 and 1 and corresponding operating ranges are highlighted. These Vcore level settings result in reduced susceptibility to the flash read issue vs levels 2 and 3.

While all Vcore settings when used under the proper Vcc and clock frequency ranges are valid for device operation, usage of Vcore level 2 and 3 settings are twice as likely to result in flash read errors at susceptible bit locations compared to levels 0 and 1.

Operating the device at an internal core voltage level 0 or 1 can reduce the likelihood of flash read error occurrence by as much as 50% versus operation at level 2 and level 3.
