MSP430F1471 Device Erratasheet

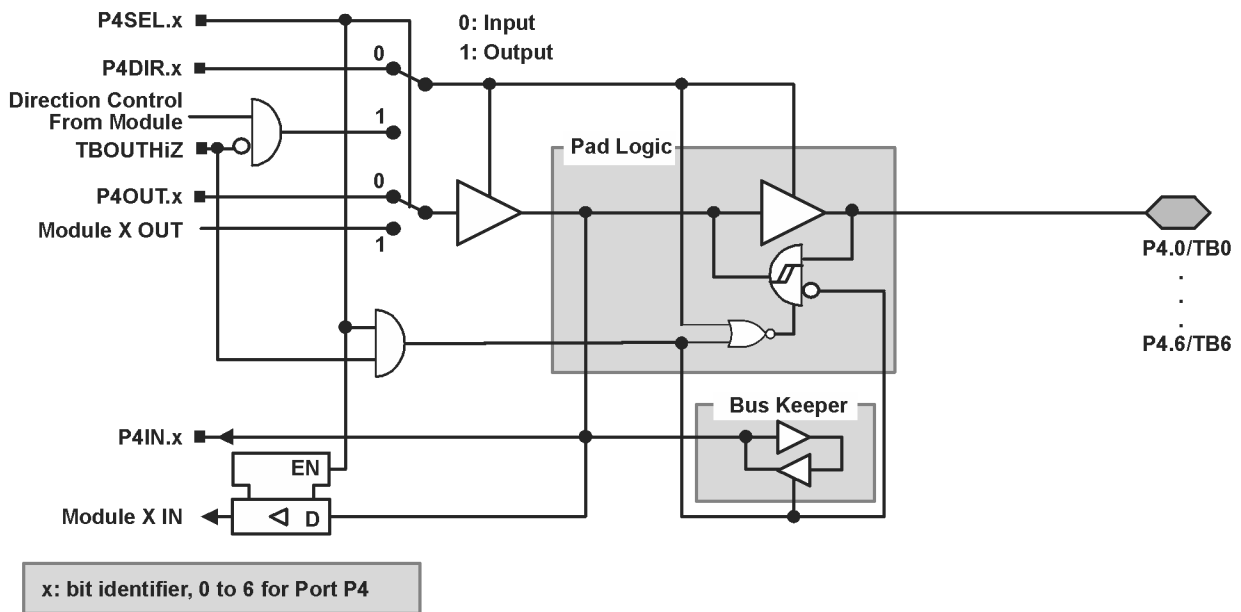
Port function as specified

TB3	<i>TIMER_B Module</i>
Category	Functional
Function	Port is switched to 3-state independent of selected function
Description	<p>Incorrect 3-state function of Ports P4.0/TB0 through P4.6/TB6 (TBoutHiZ control). If TBoutHiZ is set to high, all ports P4.0/TB0 through P4.6/TB6 are set to 3-state, independent of the P4SEL.x control signals. This means a port P4.x is switched to 3-state with TBoutHiZ, even if it is not selected for Timer_B function. In addition, the ports P4.0/TB0 through P4.6/TB6 are switched to 3-state with TBoutHiZ, even if the port direction (direction control from module) is set to input. This is in accordance with the specification description but, nevertheless, is an unexpected behavior.</p>
Workaround	No workaround.
