# MSP430F1481 Device Erratasheet

## 1 Functional Errata Revision History

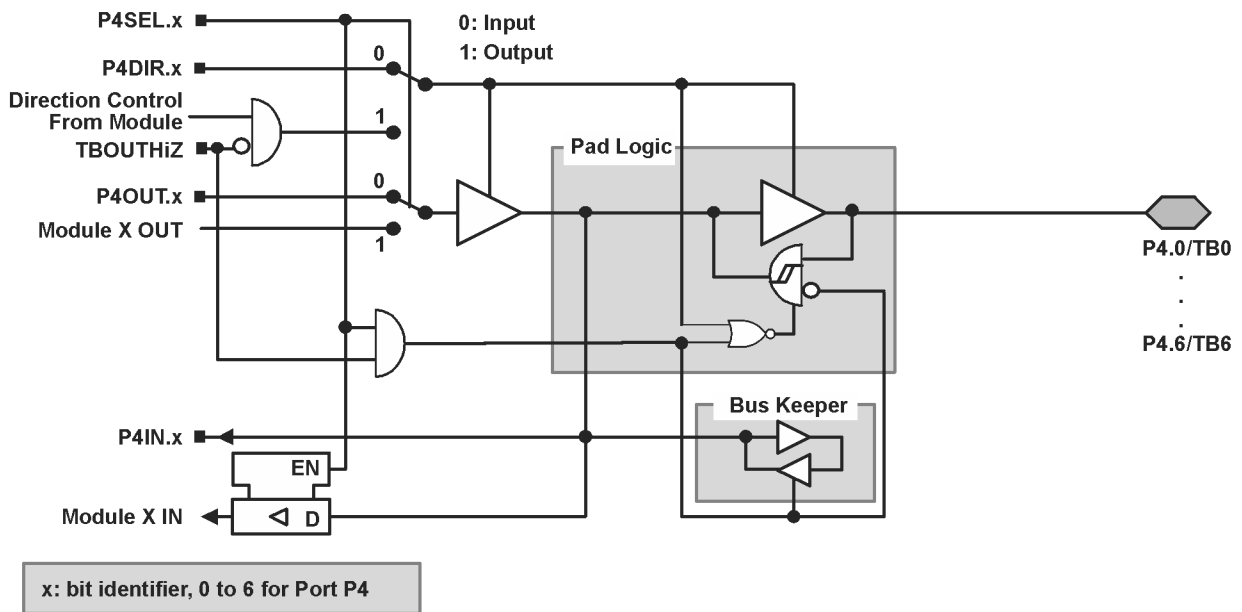
Port function as specified

port P4, P4.0 to P4.6, input/output with Schmitt-trigger

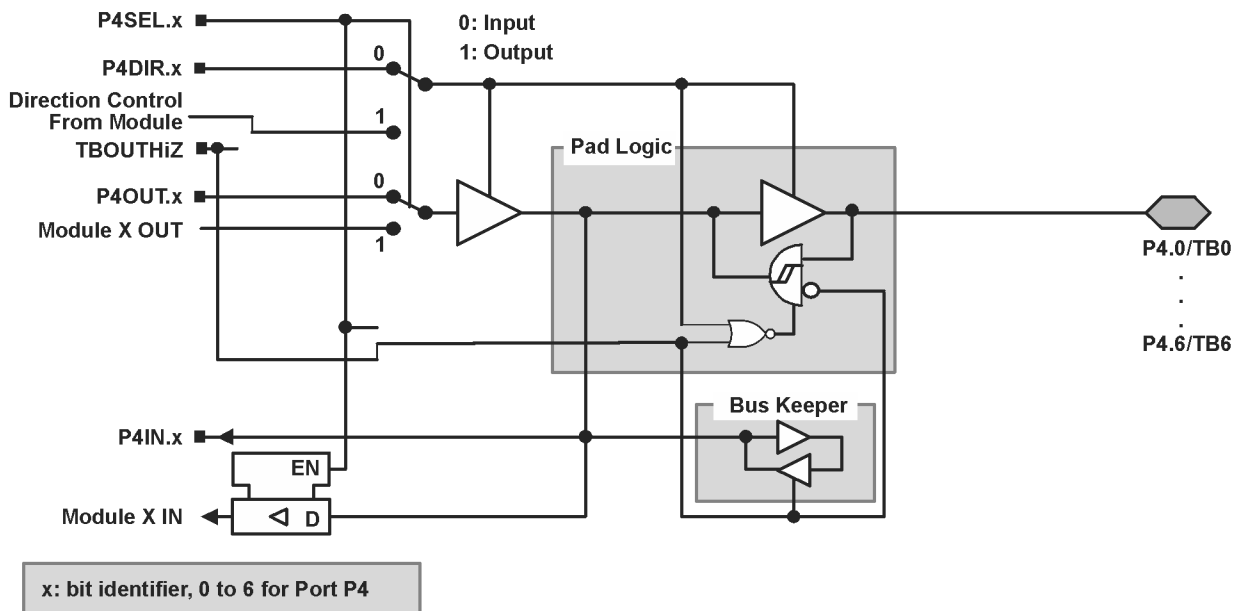
Port Realization With TB3 Bug

<b>Workaround</b>	Switch capture/compare mode to capture mode before the CCRx register increment. Switch back to compare mode afterward.
<b>TB3</b>	<b><i>TIMER_B Module</i></b>
<b>Category</b>	Functional
<b>Function</b>	Port is switched to 3-state independent of selected function
<b>Description</b>	<p>Incorrect 3-state function of Ports P4.0/TB0 through P4.6/TB6 (TBoutHiZ control). If TBoutHiZ is set to high, all ports P4.0/TB0 through P4.6/TB6 are set to 3-state, independent of the P4SEL.x control signals. This means a port P4.x is switched to 3-state with TBoutHiZ, even if it is not selected for Timer_B function. In addition, the ports P4.0/TB0 through P4.6/TB6 are switched to 3-state with TBoutHiZ, even if the port direction (direction control from module) is set to input. This is in accordance with the specification description but, nevertheless, is an unexpected behavior.</p>
<b>Workaround</b>	No workaround.

port P4, P4.0 to P4.6, input/output with Schmitt-trigger
