# MSP430F149 Device Erratasheet

## 1 Functional Errata Revision History

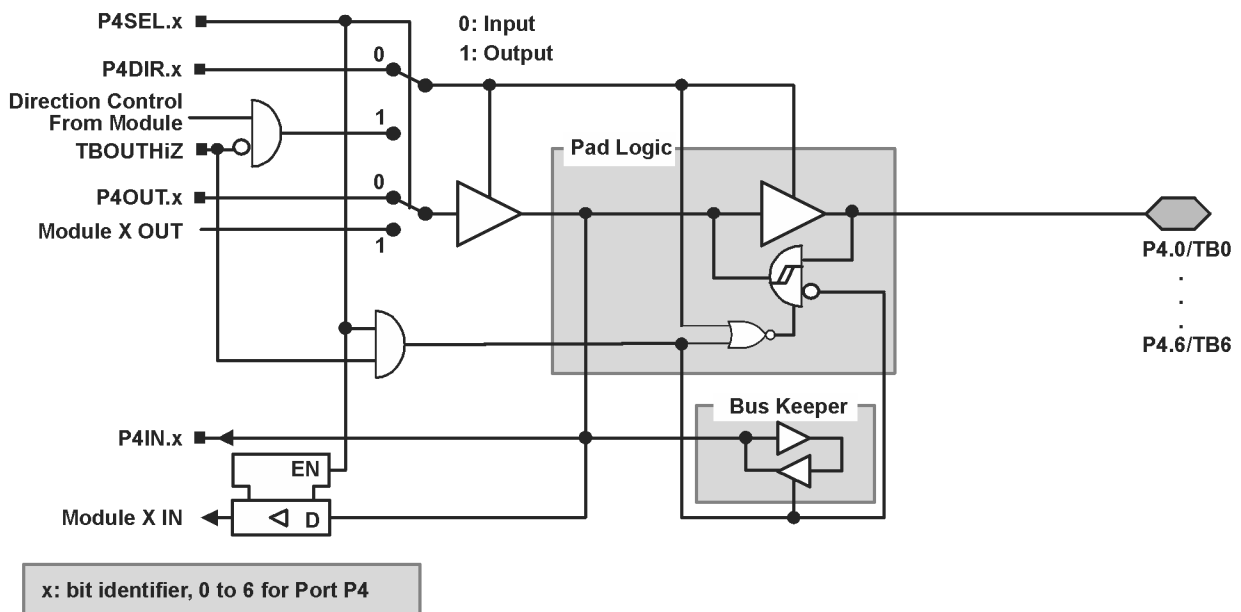
**port P4, P4.0 to P4.6, input/output with Schmitt-trigger**

**Function** Port is switched to 3-state independent of selected function

**Description** Incorrect 3-state function of Ports P4.0/TB0 through P4.6/TB6 (TBoutHiZ control). If TBoutHiZ is set to high, all ports P4.0/TB0 through P4.6/TB6 are set to 3-state, independent of the P4SEL.x control signals. This means a port P4.x is switched to 3-state with TBoutHiZ, even if it is not selected for Timer\_B function. In addition, the ports P4.0/TB0 through P4.6/TB6 are switched to 3-state with TBoutHiZ, even if the port direction (direction control from module) is set to input. This is in accordance with the specification description but, nevertheless, is an unexpected behavior.

**Workaround** No workaround.  
Port function as specified

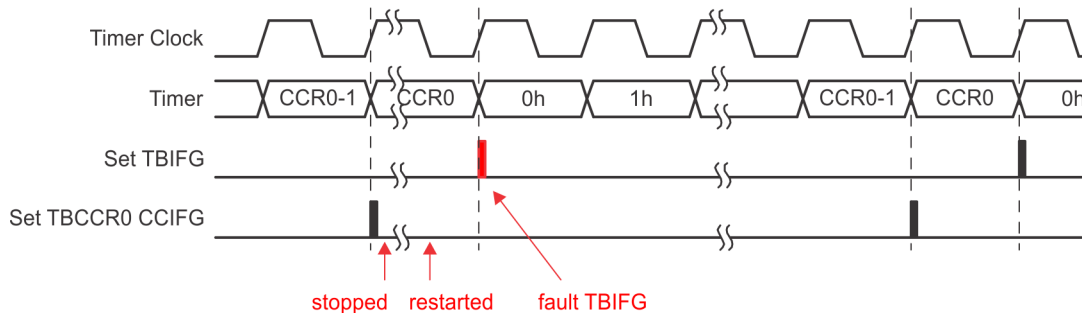
**TB24** *TIMER\_B Module*

**Function** TBIFG Flag is erroneously set after Timer B restarts in Up Mode

**Description** In Up Mode, the TBIFG flag should only be set when the timer resets from TBCCR0 to zero. However, if the Timer B is stopped at TBR = TBCCR0, then cleared (TBR=0) by setting the TBCLR bit, and finally restarted in Up Mode, the next rising edge of the TBCLK will erroneously set the TBIFG flag.

**Workaround** None.
