# MSP430F1491 Device Erratasheet

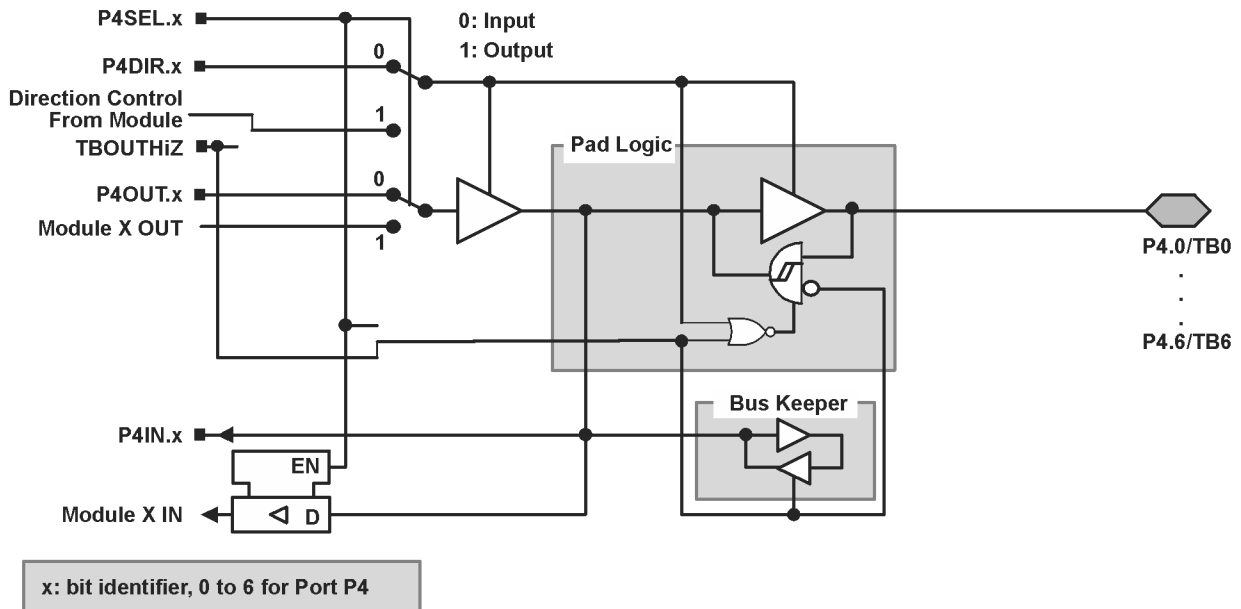
Port Realization With TB3 Bug

| <b>Function</b> | Port is switched to 3-state independent of selected function |
| <b>Description</b> | <p>Incorrect 3-state function of Ports P4.0/TB0 through P4.6/TB6 (TBoutHiZ control). If TBoutHiZ is set to high, all ports P4.0/TB0 through P4.6/TB6 are set to 3-state, independent of the P4SEL.x control signals. This means a port P4.x is switched to 3-state with TBoutHiZ, even if it is not selected for Timer_B function. In addition, the ports P4.0/TB0 through P4.6/TB6 are switched to 3-state with TBoutHiZ, even if the port direction (direction control from module) is set to input. This is in accordance with the specification description but, nevertheless, is an unexpected behavior.</p> |

| <b>Workaround</b> | No workaround. |
