MSP430F2252 Device Erratasheet

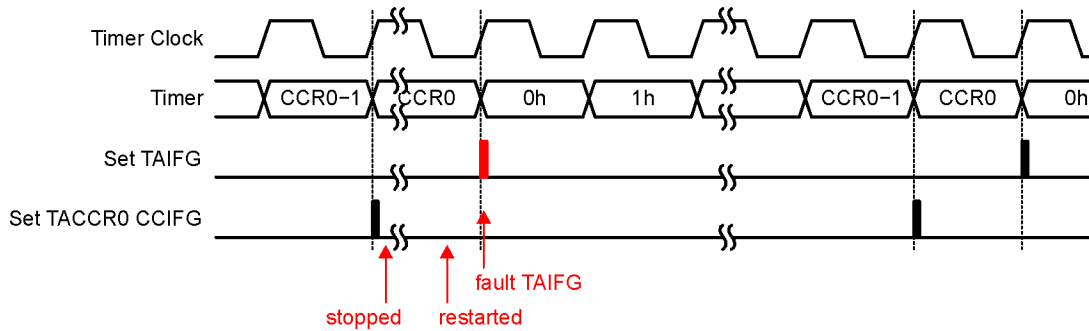
TA21 ***TIMER_A Module***

Function TAIFG Flag is erroneously set after Timer A restarts in Up Mode

Description In Up Mode, the TAIFG flag should only be set when the timer counts from TACCR0 to zero. However, if the Timer A is stopped at TAR = TACCR0, then cleared (TAR=0) by setting the TACLK bit, and finally restarted in Up Mode, the next rising edge of the TACLK will erroneously set the TAIFG flag.

Workaround None.

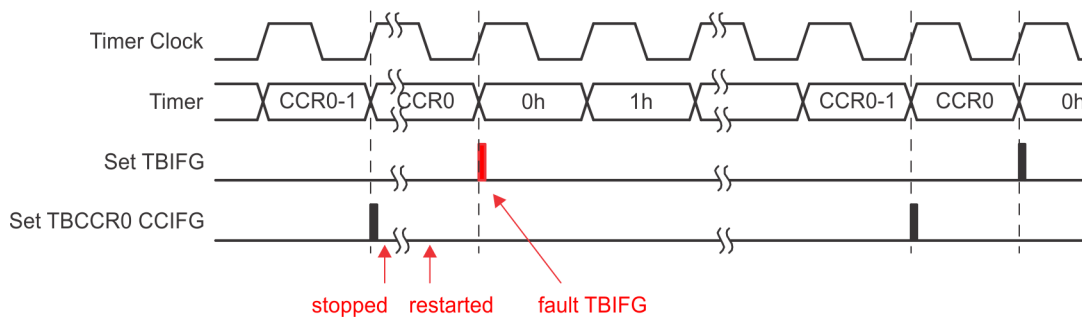
TB24 *TIMER_B Module*

Function TBIFG Flag is erroneously set after Timer B restarts in Up Mode

Description In Up Mode, the TBIFG flag should only be set when the timer resets from TBCCR0 to zero. However, if the Timer B is stopped at $TBR = TBCCR0$, then cleared ($TBR=0$) by setting the TBCLR bit, and finally restarted in Up Mode, the next rising edge of the TBCLK will erroneously set the TBIFG flag.

Workaround None.
