## MSP430F233 Device Erratasheet

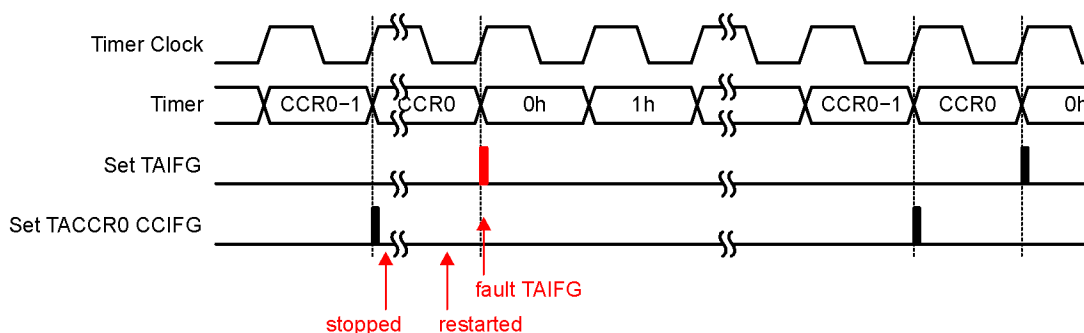
**TA21** *TIMER\_A Module*

**Function** TAIFG Flag is erroneously set after Timer A restarts in Up Mode

**Description** In Up Mode, the TAIFG flag should only be set when the timer counts from TACCR0 to zero. However, if the Timer A is stopped at TAR = TACCR0, then cleared (TAR=0) by setting the TACLR bit, and finally restarted in Up Mode, the next rising edge of the TACLK will erroneously set the TAIFG flag.

**Workaround** None.
