MSP430F2370 Device Erratasheet

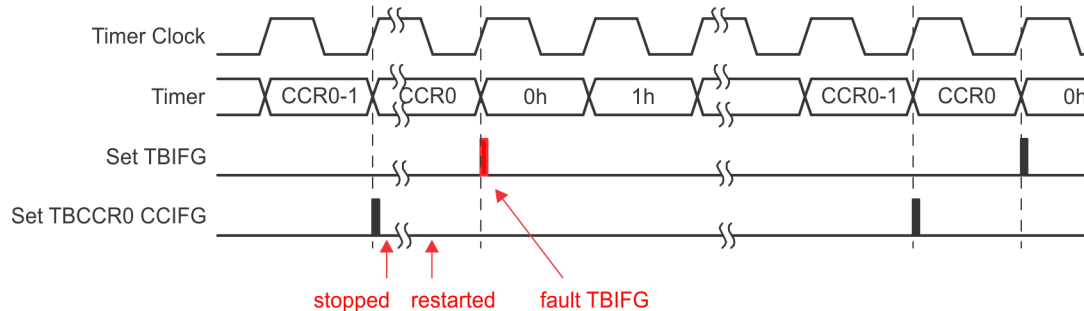
**TB24** ***TIMER\_B Module***

| <b>Function</b> | TBIFG Flag is erroneously set after Timer B restarts in Up Mode |

**Description** In Up Mode, the TBIFG flag should only be set when the timer resets from TBCCR0 to zero. However, if the Timer B is stopped at TBR = TBCCR0, then cleared (TBR=0) by setting the TBCLR bit, and finally restarted in Up Mode, the next rising edge of the TBCLK will erroneously set the TBIFG flag.

**Workaround** None.
