MSP430F2416 Device Erratasheet

1 Functional Errata Revision History

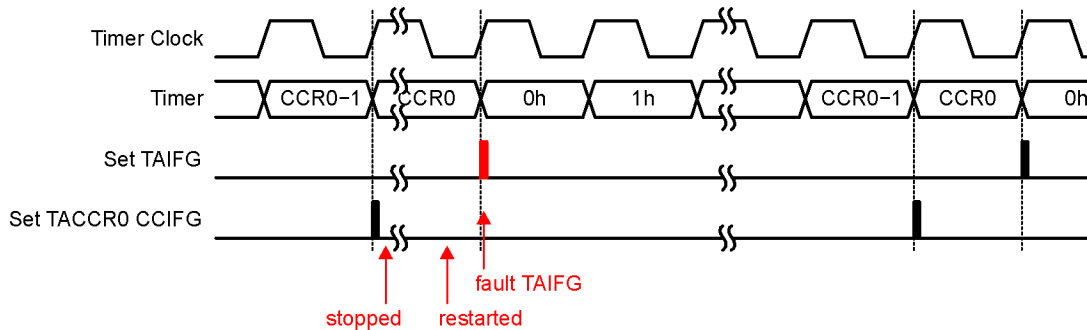
TA21 *TIMER_A Module*

Function TAIFG Flag is erroneously set after Timer A restarts in Up Mode

Description In Up Mode, the TAIFG flag should only be set when the timer counts from TACCR0 to zero. However, if the Timer A is stopped at TAR = TACCR0, then cleared (TAR=0) by setting the TACLRL bit, and finally restarted in Up Mode, the next rising edge of the TACLK will erroneously set the TAIFG flag.

Workaround None.

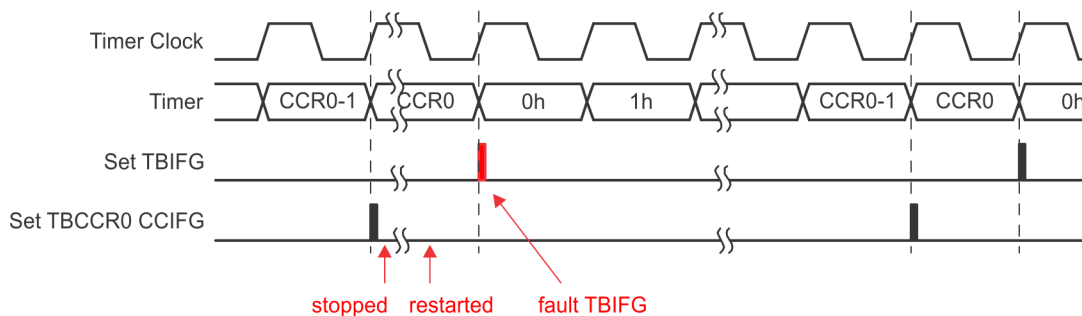
TB24 *TIMER_B Module*

Function TBIFG Flag is erroneously set after Timer B restarts in Up Mode

Description In Up Mode, the TBIFG flag should only be set when the timer resets from TBCCR0 to zero. However, if the Timer B is stopped at $TBR = TBCCR0$, then cleared ($TBR=0$) by setting the TBCLR bit, and finally restarted in Up Mode, the next rising edge of the TBCLK will erroneously set the TBIFG flag.

Workaround None.
