MSP430F2419 Device Erratasheet

1 Functional Errata Revision History

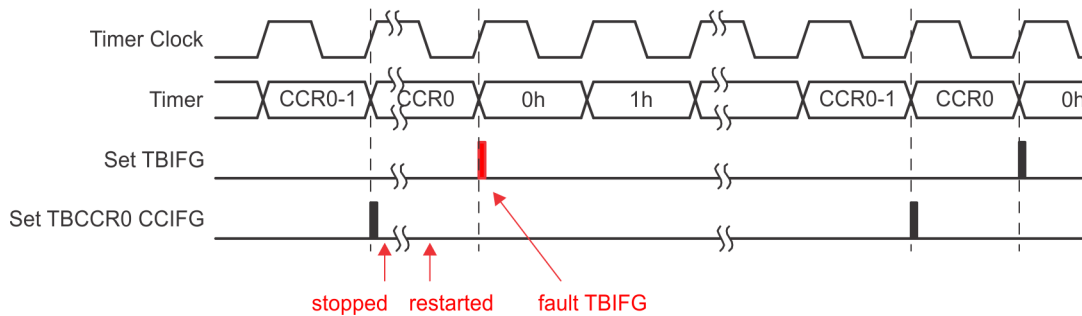
Description In Up Mode, the TBIFG flag should only be set when the timer resets from TBCCR0 to zero. However, if the Timer B is stopped at $TBR = TBCCR0$, then cleared ($TBR=0$) by setting the TBCLR bit, and finally restarted in Up Mode, the next rising edge of the TBCLK will erroneously set the TBIFG flag.

Workaround None.
