MSP430F2471 Device Erratasheet

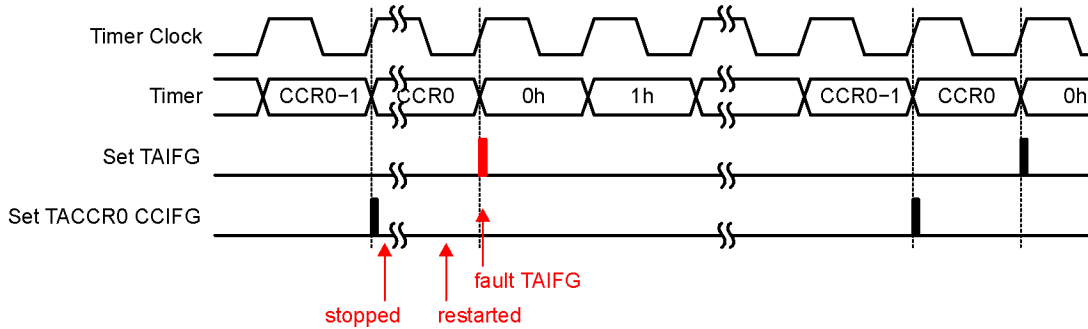
TA21

Function TAIFG Flag is erroneously set after Timer A restarts in Up Mode

Description In Up Mode, the TAIFG flag should only be set when the timer counts from TACCR0 to zero. However, if the Timer A is stopped at TAR = TACCR0, then cleared (TAR=0) by setting the TACLK bit, and finally restarted in Up Mode, the next rising edge of the TACLK will erroneously set the TAIFG flag.

Workaround None.

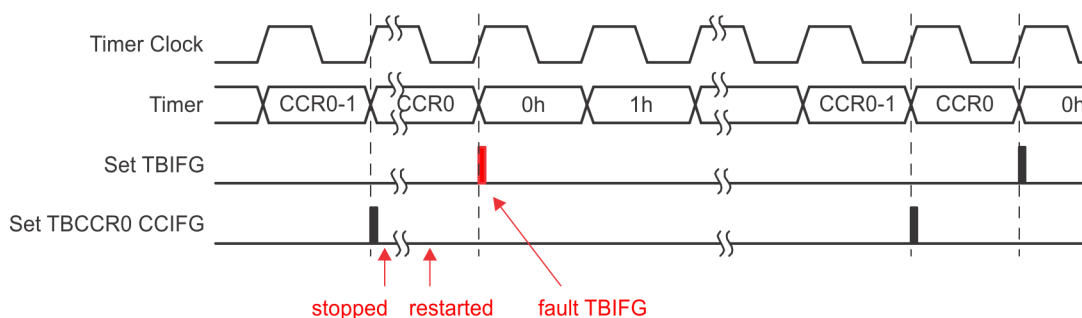
TB24 *TIMER_B Module*

Function TBIFG Flag is erroneously set after Timer B restarts in Up Mode

Description In Up Mode, the TBIFG flag should only be set when the timer resets from TBCCR0 to zero. However, if the Timer B is stopped at $TBR = TBCCR0$, then cleared ($TBR=0$) by setting the TBCLR bit, and finally restarted in Up Mode, the next rising edge of the TBCLK will erroneously set the TBIFG flag.

Workaround None.
