## MSP430F2617 Device Erratasheet

### 1 Functional Errata Revision History

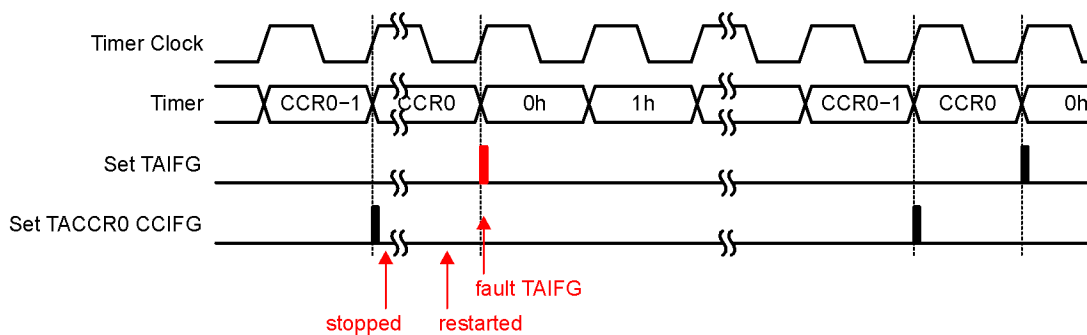
**Function** TAIFG Flag is erroneously set after Timer A restarts in Up Mode

**Description** In Up Mode, the TAIFG flag should only be set when the timer counts from TACCR0 to zero. However, if the Timer A is stopped at TAR = TACCR0, then cleared (TAR=0) by setting the TACLR bit, and finally restarted in Up Mode, the next rising edge of the TACLK will erroneously set the TAIFG flag.

**Workaround** None.

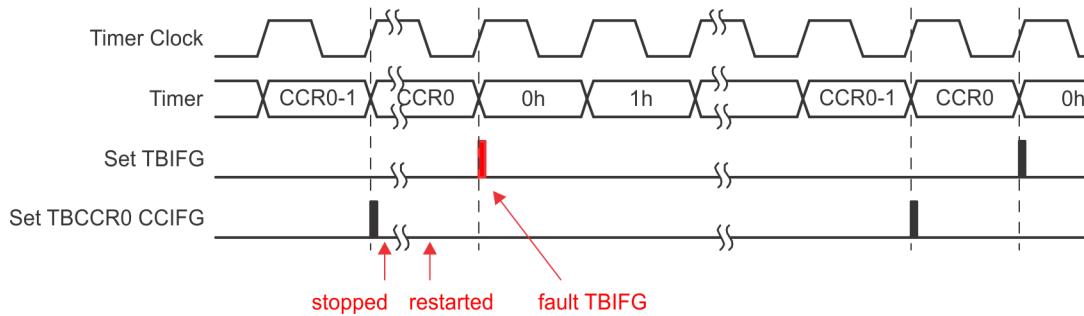
<b>Description</b>	The first increment of TBR after any timer clear event (POR/TBCLR) happens immediately following the first positive edge of the selected clock source (INCLK, SMCLK, ACLK, or TBCLK). This is independent of the clock input divider settings (ID0, ID1). All following TBR increments are performed correctly with the selected IDx settings.
<b>Workaround</b>	None
<b>TB19</b>	<b><i>TIMER_B Module</i></b>
<b>Category</b>	Functional
<b>Function</b>	TBIFG/TBIV not updated after access to TBIV
<b>Description</b>	After any access to TBIV, the TBIFG flag should automatically be cleared and the TBIV value should be updated to reflect the new state of Timer_B interrupts. However, they are not updated.
<b>Workaround</b>	None
<b>TB24</b>	<b><i>TIMER_B Module</i></b>
<b>Category</b>	Functional
<b>Function</b>	TBIFG Flag is erroneously set after Timer B restarts in Up Mode
<b>Description</b>	In Up Mode, the TBIFG flag should only be set when the timer resets from TBCCR0 to zero. However, if the Timer B is stopped at TBR = TBCCR0, then cleared (TBR=0) by setting the TBCLR bit, and finally restarted in Up Mode, the next rising edge of the TBCLK will erroneously set the TBIFG flag.

**Workaround** None.
