## MSP430F2618 Device Erratasheet

### 1 Functional Errata Revision History

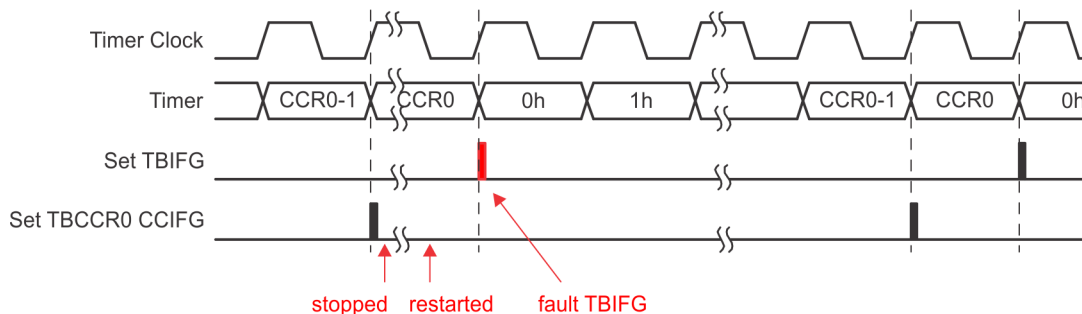
**Function** TBIFG Flag is erroneously set after Timer B restarts in Up Mode

**Description** In Up Mode, the TBIFG flag should only be set when the timer resets from TBCCR0 to zero. However, if the Timer B is stopped at TBR = TBCCR0, then cleared (TBR=0) by setting the TBCLR bit, and finally restarted in Up Mode, the next rising edge of the TBCLK will erroneously set the TBIFG flag.

**Workaround** None.
