MSP430F427A Device Erratasheet

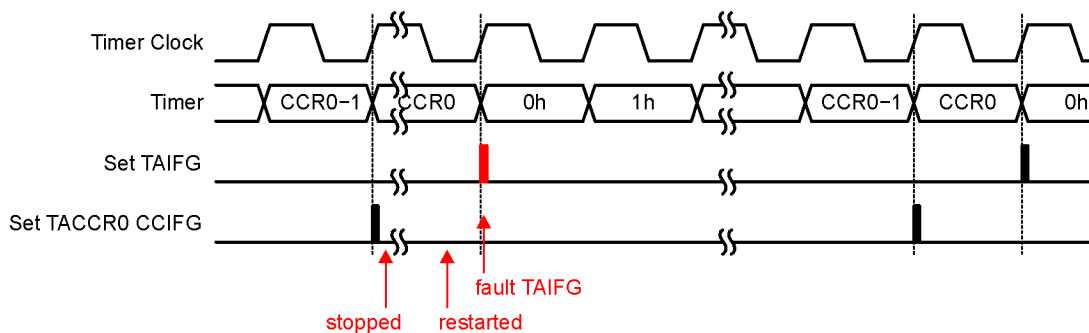
TA21 *TIMER_A Module*

Function TAIFG Flag is erroneously set after Timer A restarts in Up Mode

Description In Up Mode, the TAIFG flag should only be set when the timer counts from TACCR0 to zero. However, if the Timer A is stopped at TAR = TACCR0, then cleared (TAR=0) by setting the TACLRL bit, and finally restarted in Up Mode, the next rising edge of the TACLK will erroneously set the TAIFG flag.

Workaround None.
