MSP430F448 Device Erratasheet

1 Functional Errata Revision History

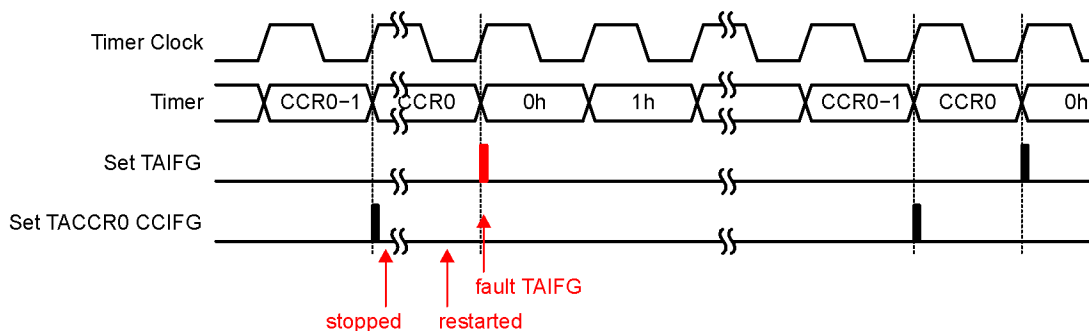
TA21 *TIMER_A Module*

Function TAIFG Flag is erroneously set after Timer A restarts in Up Mode

Description In Up Mode, the TAIFG flag should only be set when the timer counts from TACCR0 to zero. However, if the Timer A is stopped at TAR = TACCR0, then cleared (TAR=0) by setting the TACLK bit, and finally restarted in Up Mode, the next rising edge of the TACLK will erroneously set the TAIFG flag.

Workaround None.

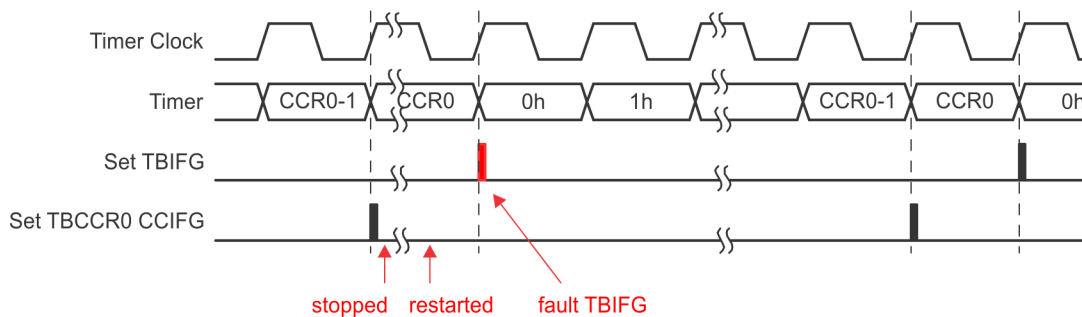
TB24 *TIMER_B Module*

Function TBIFG Flag is erroneously set after Timer B restarts in Up Mode

Description In Up Mode, the TBIFG flag should only be set when the timer resets from TBCCR0 to zero. However, if the Timer B is stopped at TBR = TBCCR0, then cleared (TBR=0) by setting the TBCLR bit, and finally restarted in Up Mode, the next rising edge of the TBCLK will erroneously set the TBIFG flag.

Workaround None.
