MSP430F4491 Device Erratasheet

1 Functional Errata Revision History

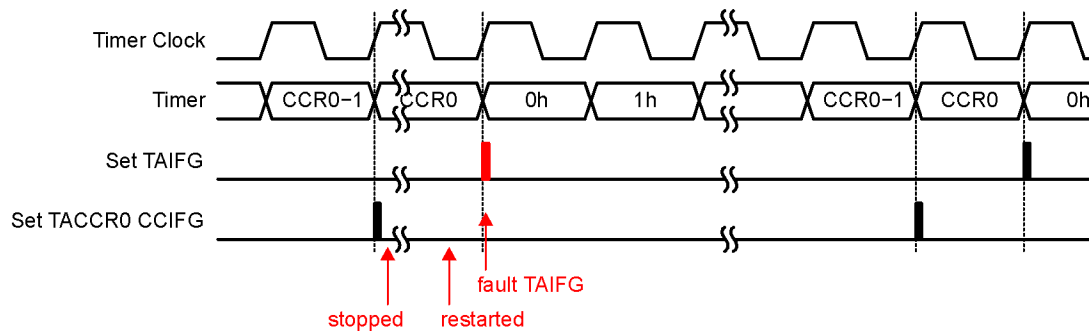
TA21
TIMER_A Module

Category	Functional
Function	TAIFG Flag is erroneously set after Timer A restarts in Up Mode
Description	In Up Mode, the TAIFG flag should only be set when the timer counts from TACCR0 to zero. However, if the Timer A is stopped at TAR = TACCR0, then cleared (TAR=0) by setting the TACLK bit, and finally restarted in Up Mode, the next rising edge of the TACLK will erroneously set the TAIFG flag.

Workaround None.

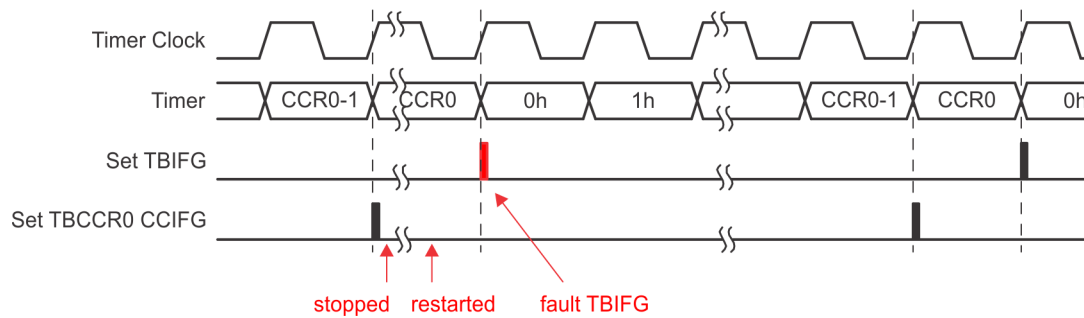
TB24 *TIMER_B Module*

Function TBIFG Flag is erroneously set after Timer B restarts in Up Mode

Description In Up Mode, the TBIFG flag should only be set when the timer resets from TBCCR0 to zero. However, if the Timer B is stopped at $TBR = TBCCR0$, then cleared ($TBR=0$) by setting the TBCLR bit, and finally restarted in Up Mode, the next rising edge of the TBCLK will erroneously set the TBIFG flag.

Workaround None.
