# MSP430F46181 Device Erratasheet

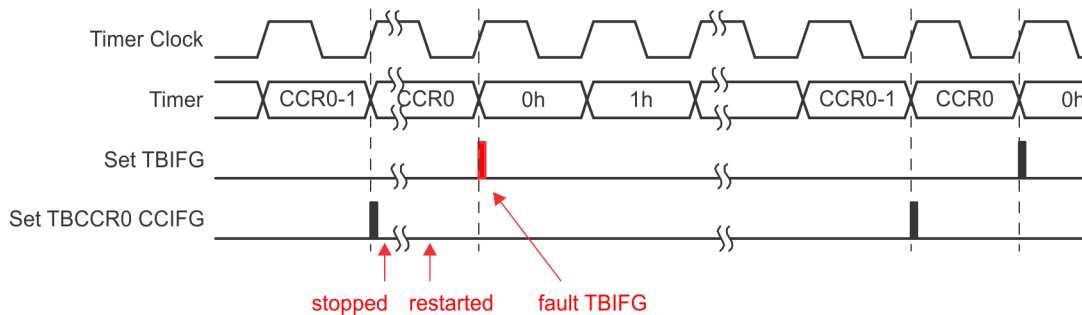
**TB24** *TIMER\_B Module*

**Function** TBIFG Flag is erroneously set after Timer B restarts in Up Mode

**Description** In Up Mode, the TBIFG flag should only be set when the timer resets from TBCCR0 to zero. However, if the Timer B is stopped at TBR = TBCCR0, then cleared (TBR=0) by setting the TBCLR bit, and finally restarted in Up Mode, the next rising edge of the TBCLK will erroneously set the TBIFG flag.

**Workaround** None.
