MSP430F47186 Device Erratasheet

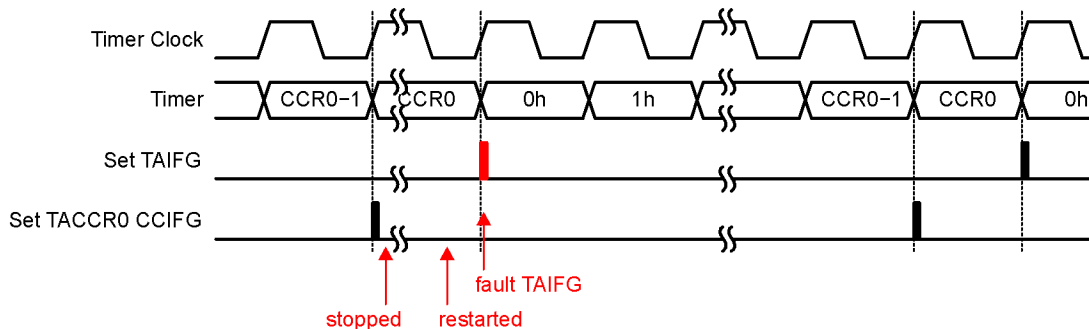
TA21 *TIMER_A Module*

Function TAIFG Flag is erroneously set after Timer A restarts in Up Mode

Description In Up Mode, the TAIFG flag should only be set when the timer counts from TACCR0 to zero. However, if the Timer A is stopped at $TAR = TACCR0$, then cleared ($TAR=0$) by setting the TACLR bit, and finally restarted in Up Mode, the next rising edge of the TACLK will erroneously set the TAIFG flag.

Workaround None.

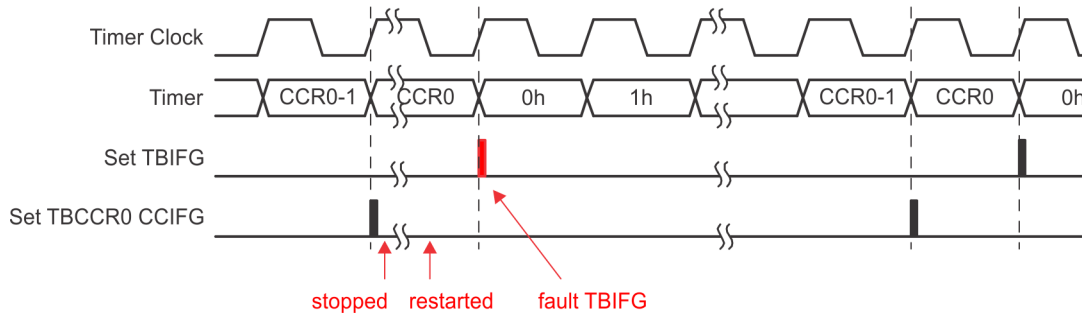
TB24
TIMER_B Module

TBIFG Flag is erroneously set after Timer B restarts in Up Mode

In Up Mode, the TBIFG flag should only be set when the timer resets from TBCCR0 to zero. However, if the Timer B is stopped at $TBR = TBCCR0$, then cleared ($TBR=0$) by setting the TBCLR bit, and finally restarted in Up Mode, the next rising edge of the

TBCLK will erroneously set the TBIFG flag.

Workaround None.
