MSP430F5435A Device Erratasheet

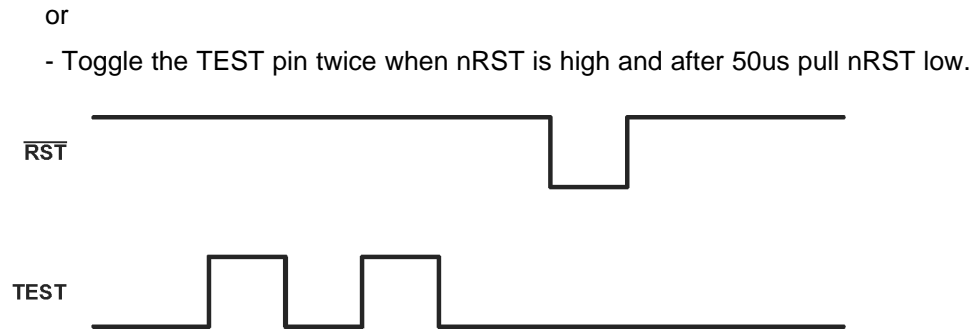
To exit the BSL one of the following methods must be used.

- A Power cycle

Note: This toggling of TEST pins is not subject to timing constraints. The appropriate level transitions on TEST pin, followed by a RST pulse after 50us, are sufficient to trigger an exit from BSL mode.

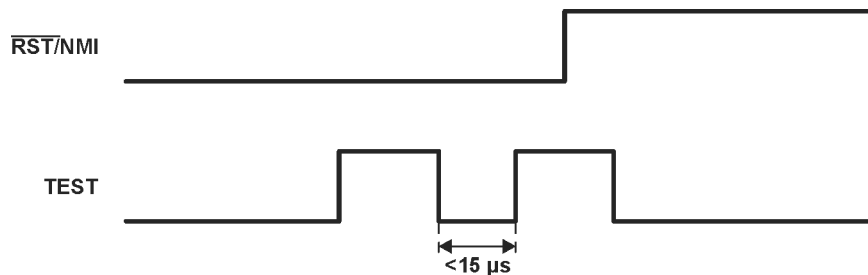
Function BSL entry sequence is subject to specific timing requirements

Description The BSL entry sequence requires that the low phase of the TEST/SBWTCK pin does not exceed 15us. This timing requirement is faster than most PC serial ports can provide, as shown in the following picture. If this requirement is not met, the entry sequence fails and the SYSBSLIND is not set.

Workaround An external hardware solution is recommended to provide the appropriate BSL entry sequence. See [http://processors.wiki.ti.com/index.php/BSL_\(MSP430\)](http://processors.wiki.ti.com/index.php/BSL_(MSP430)) for recommendations on available BSL hardware.
