MSP430F5438A Device Erratasheet

The revision of the device can be identified by the revision letter on the [Package Markings](#) or by the [HW_ID](#) located inside the TLV structure of the device

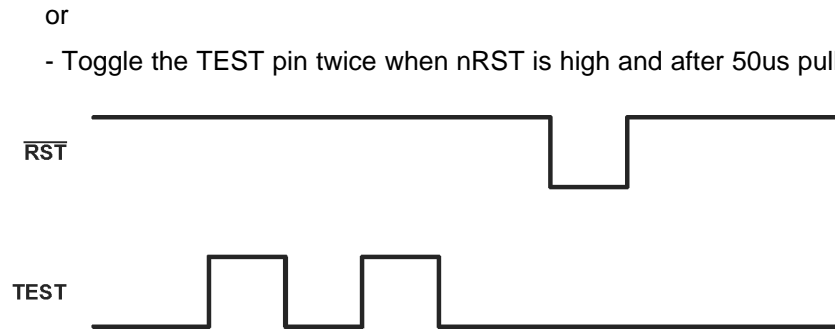
To exit the BSL one of the following methods must be used.

- A Power cycle

Note: This toggling of TEST pins is not subject to timing constraints. The appropriate level transitions on TEST pin, followed by a RST pulse after 50us, are sufficient to trigger an exit from BSL mode.

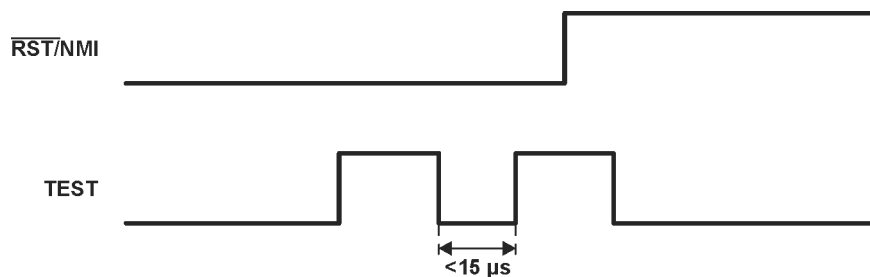
Function BSL entry sequence is subject to specific timing requirements

Description The BSL entry sequence requires that the low phase of the TEST/SBWTCK pin does not exceed 15us. This timing requirement is faster than most PC serial ports can provide, as shown in the following picture. If this requirement is not met, the entry sequence fails and the SYSBSLIND is not set.

Workaround An external hardware solution is recommended to provide the appropriate BSL entry sequence. See [http://processors.wiki.ti.com/index.php/BSL_\(MSP430\)](http://processors.wiki.ti.com/index.php/BSL_(MSP430)) for recommendations on available BSL hardware.
