MSP430F5514 Device Erratasheet

The revision of the device can be identified by the revision letter on the [Package Markings](#) or by the [HW_ID](#) located inside the TLV structure of the device

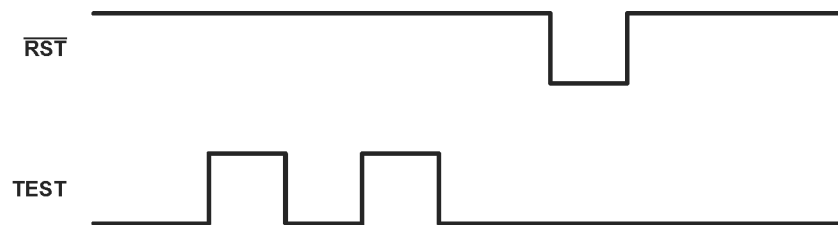
- Toggle the TEST pin twice when nRST is high and after 50us pull nRST low.

Note: This toggling of TEST pins is not subject to timing constraints. The appropriate level transitions on TEST pin, followed by a RST pulse after 50us, are sufficient to trigger an exit from BSL mode.
