MSP430F5631 Device Erratasheet

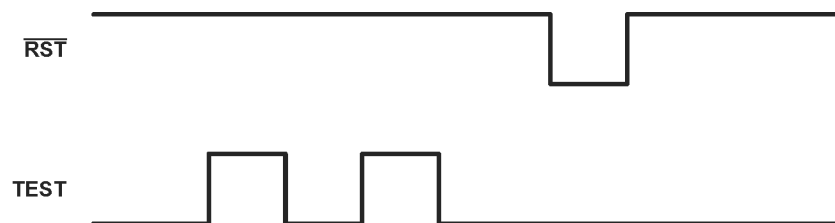
Function BSL does not exit to application code

Description The methods used to exit the BSL per MSP430 Programming Via the Bootstrap Loader ([SLAU319](#)) are invalid.

Workaround To exit the BSL one of the following methods must be used.

- A Power cycle
- or
- Toggle the TEST pin twice when nRST is high and after 50us pull nRST low.

Note: This toggling of TEST pins is not subject to timing constraints. The appropriate level transitions on TEST pin, followed by a RST pulse after 50us, are sufficient to trigger an exit from BSL mode.
